# SERVICE BULLETIN

## ENDPLATE SPAR TUBE (VERTICAL STABILIZER) GREASING PROCEDURE

All McDonnell Douglas Helicopter Systems (MDHS) MD900 helicopters, serial number 900-00010 thru 900-00051.

Empennage Build-Up Assembly (P/N 90001340102).

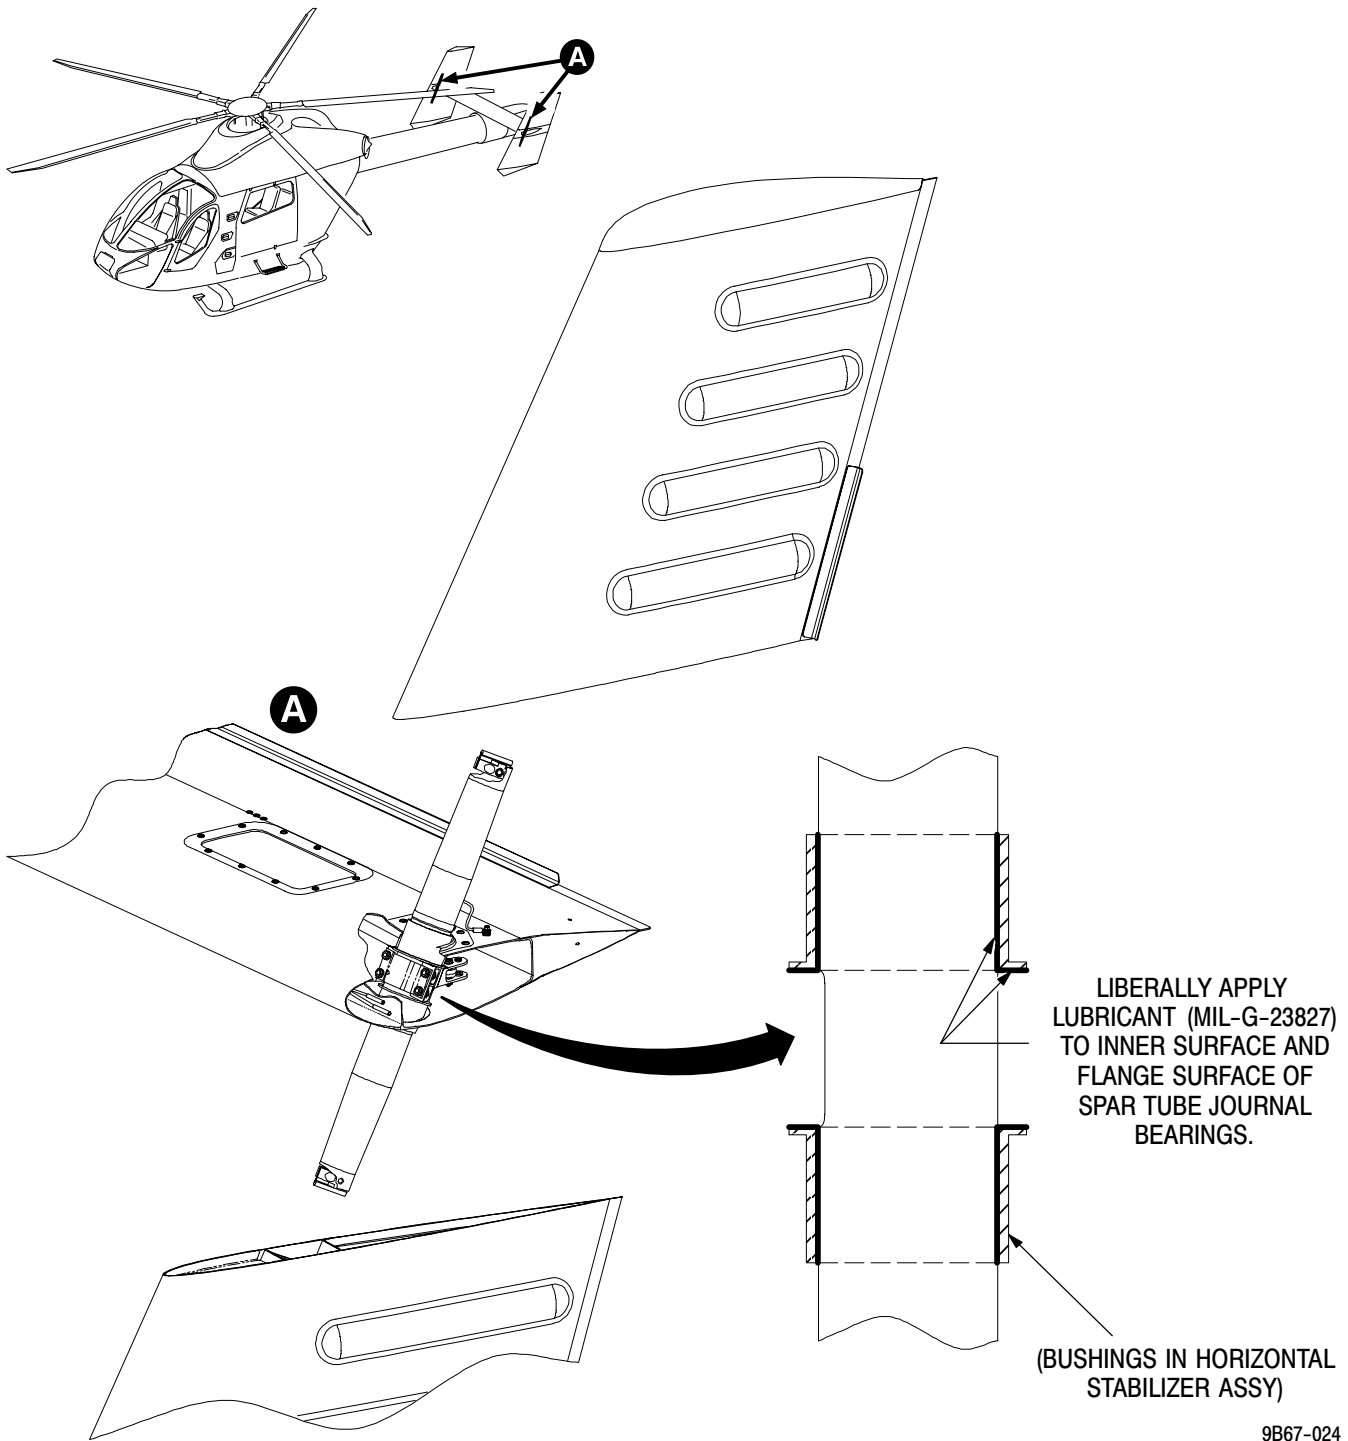
Figure 1. Vertical Fin Greasing Procedure

To prevent possible binding of the empennage controls during operation of the helicopter which may result in reduced yaw stability.

- (2). If required, remove any scratches using 600 grit paper on the spar to bushing surfaces. Clean any debris using a clean cloth and isopropyl alcohol.
- (3). Liberally apply lubricant (MIL-G-23827) to inner surface and flange surface of journal bearings as shown in Figure 1.
- (4). Reinstall spar tubes per Rotorcraft Maintenance Manual (CSP-900RMM-2; Spar Tube Assembly Installation).
