SERVICE BULLETIN

MAIN ROTOR HUB INSPECTION

All McDonnell Douglas Helicopter Systems (MDHS) MD900 helicopters, serial number 900-0002 thru 900-0057.

Main Rotor Upper Hub Assembly (P/N 900R2101006-101, -103, and -105)

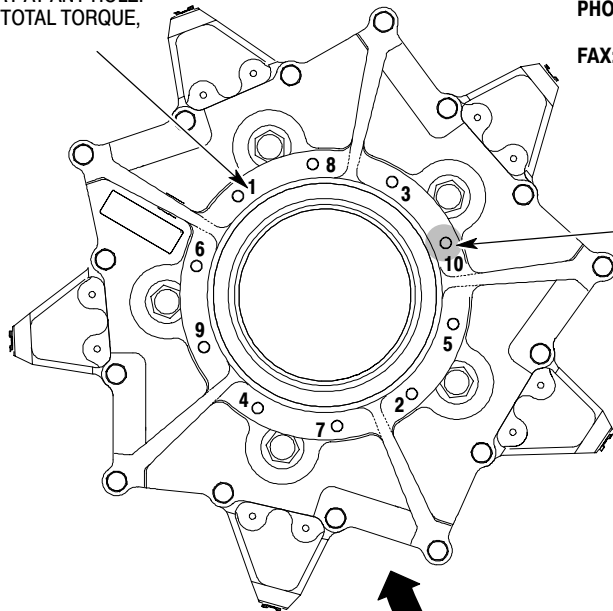
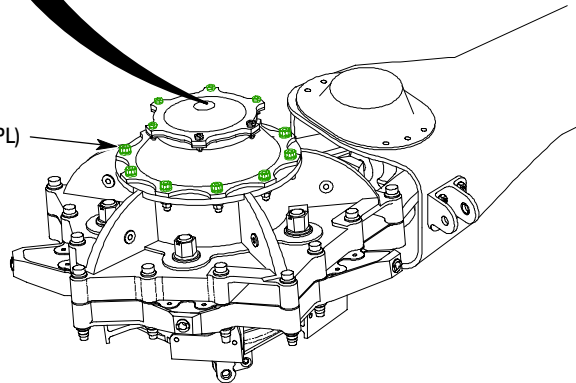
Figure 1. Main Rotor Upper Hub Assembly Inspection.

To inspect the main rotor upper hub assembly for cracks leading from the drive plate attach bolt holes. Failure to comply with the requirements of this Service Bulletin may result in the loss of drive to the main rotor assembly which would require an emergency/urgent landing of the aircraft.

AREA AROUND BOLT HOLES TO BE INSPECTED FOR CRACKING (10 PL)

- (1). If present, remove sealant from affected hardware.
- (2). Using an indelible marker, number the main rotor drive plate attachment fastener torque sequence onto the drive plate (Ref. Figure 1).

- (5). Using paint stripper (C313) and cleaning solvent (C420) remove paint from the mating surface of the main rotor upper hub assembly (Ref. CSP-SPM and Figure 1).
- (6). If any paint is present on the lower mating surface of the main rotor drive plate, remove paint (Ref. step (5)).
- (7). Using a 10X magnifying glass, inspect the area around the ten (10) mating fastener holes of the main rotor upper hub assembly for any suspected evidence of cracking. If any crack is verified replace the discrepant parts per the Rotorcraft Maintenance Manual (CSP-900RMM-2, Section 62-20-00).

- (9). Reinstall the main rotor drive plate onto a serviceable main rotor upper hub assembly per the Rotorcraft Maintenance Manual (CSP-900RMM-2, Section 63-10-00). Torque nuts to 160-180 in-lbs (beyond locking torque) in the sequence shown (Ref. Figure 1).

1. MAIN ROTOR DRIVE PLATE ATTACHMENT HARDWARE TORQUE SEQUENCE.
2. NUMBERING MAY START AT ANY HOLE.
3. TORQUE NUTS TO 1/2 TOTAL TORQUE, THEN FULL TORQUE.
