SERVICE BULLETIN

A612 FORWARD INTERCONNECT PANEL MODIFICATION

MD-900 Helicopters, serial number MD900-00008 thru MD900-00051.

Forward Interconnect Panel PN: 900E2750612-ALL.

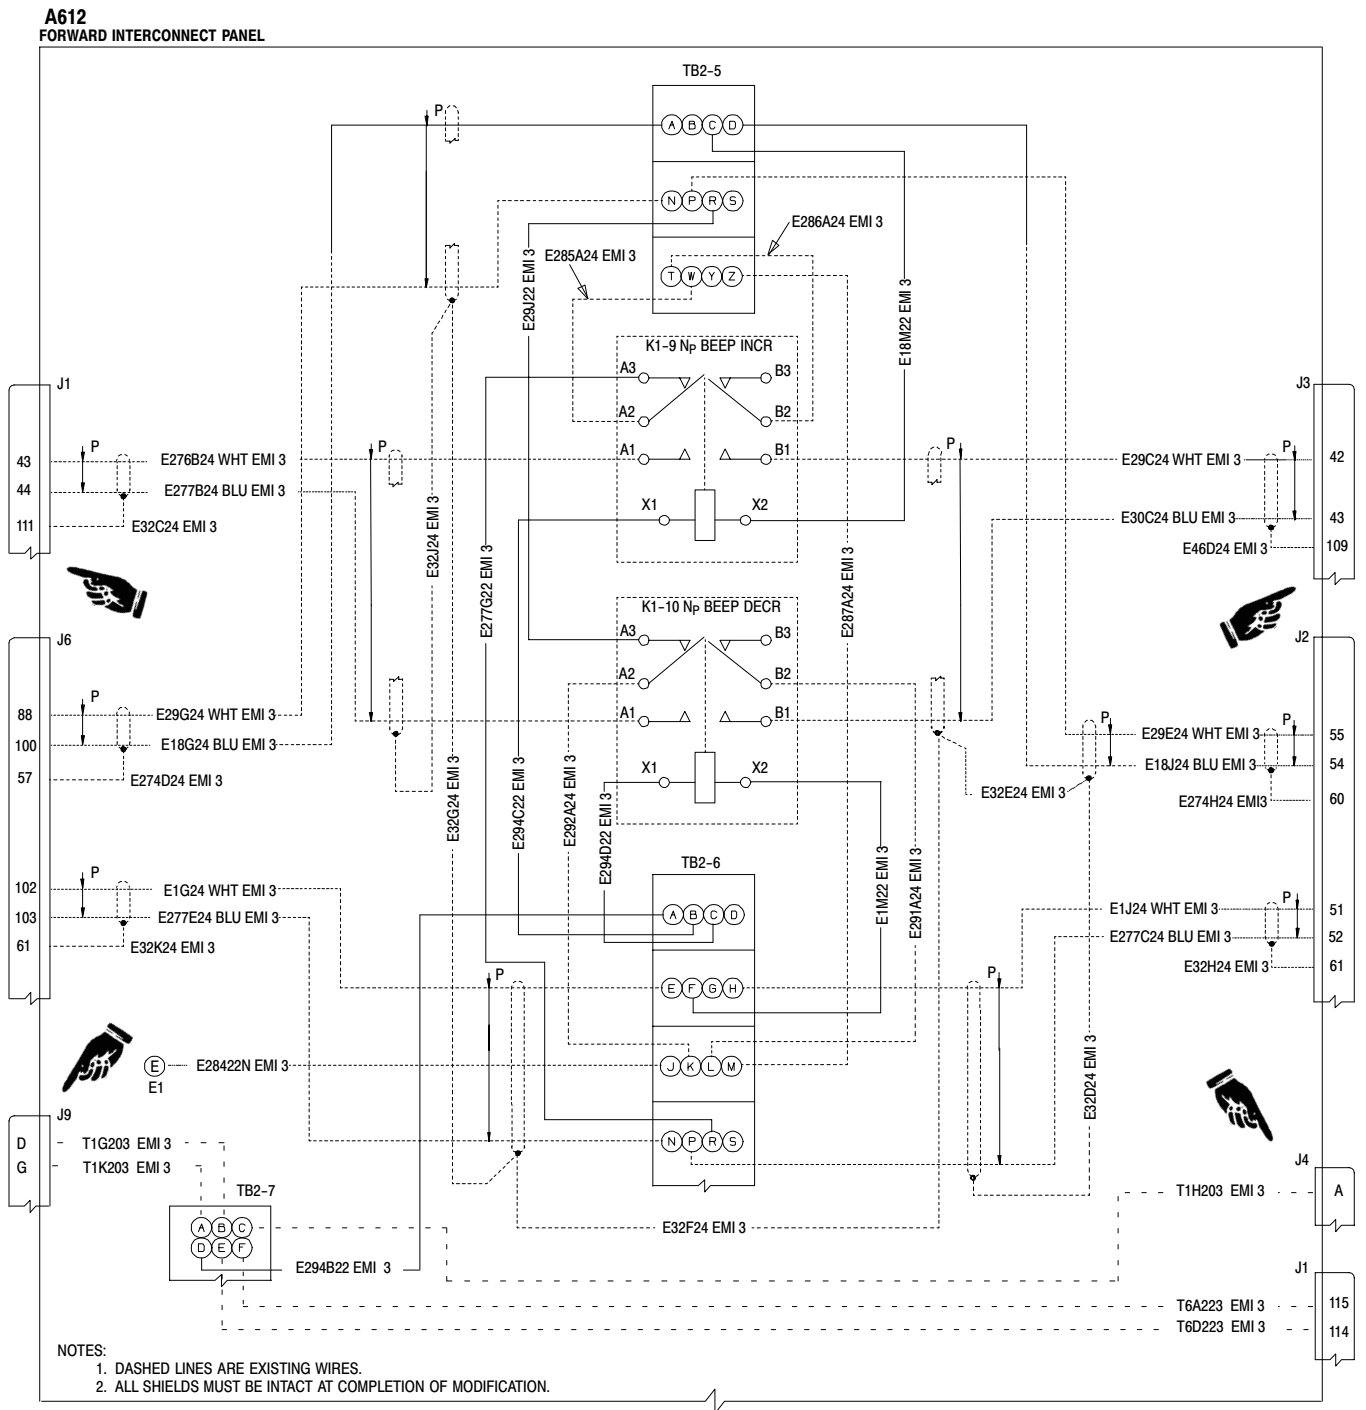
Figure 1. Modification Wiring Diagram

Wiring in the collective stick(s) wire harness is protected by a circuit breaker that is too large for the wire size. Not complying with this Bulletin in conjunction with a short circuit condition may result in a fire or unpredictable operation of any collective head control functions.

This Bulletin provides the owner/operator with information to modify the Forward Interconnect Panel. This modification re-configures the electrical circuit to use the wires installed in the collective sticks as the ground path instead of the power path.

- (11). Install wire E29J22 EMI 3 from TB2-5R to K10-A3.
- (12). Install wire E294D22 EMI 3 from TB2-6C to K10-X1.
- (13). Install wire E18M22 EMI 3 from TB2-5C to K9-X2.

- (14). Install wire E1M22 EMI 3 from TB2-6F to K10-X2.
- (15). Install wire E277G22 EMI 3 from TB2-6R to K9-A3.
- (16). Install wire E294B22 EMI 3 from TB2-6A to TB2-7D.

- (17). Install wire E294C22 EMI 3 from TB2-6B to K9-X1.
- (18). Remove wire E18G24 BLU EMI 3 from TB2-6C and install in TB2-5A. Splice wire if necessary (Ref. CSP-900RMM-3).

- (19). Remove wire E18J24 BLU EMI 3 from TB2-6D and install in TB2-5D. Splice wire if necessary (Ref. CSP-900RMM-3).
- (20). Tie new wires into existing wire harness.
