SERVICE BULLETIN

ELECTRICAL LOAD CENTER INSPECTION AND REWORK

All MD-900 helicopters, serial number 900-00052 thru 900-00076.

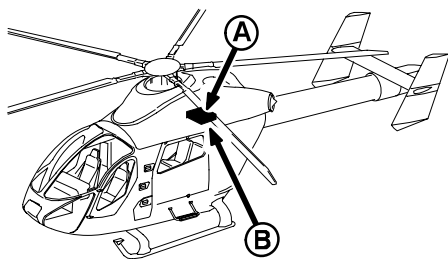
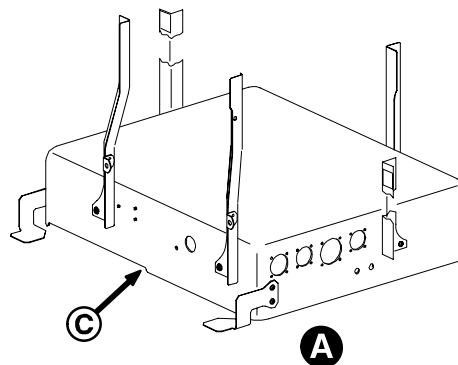
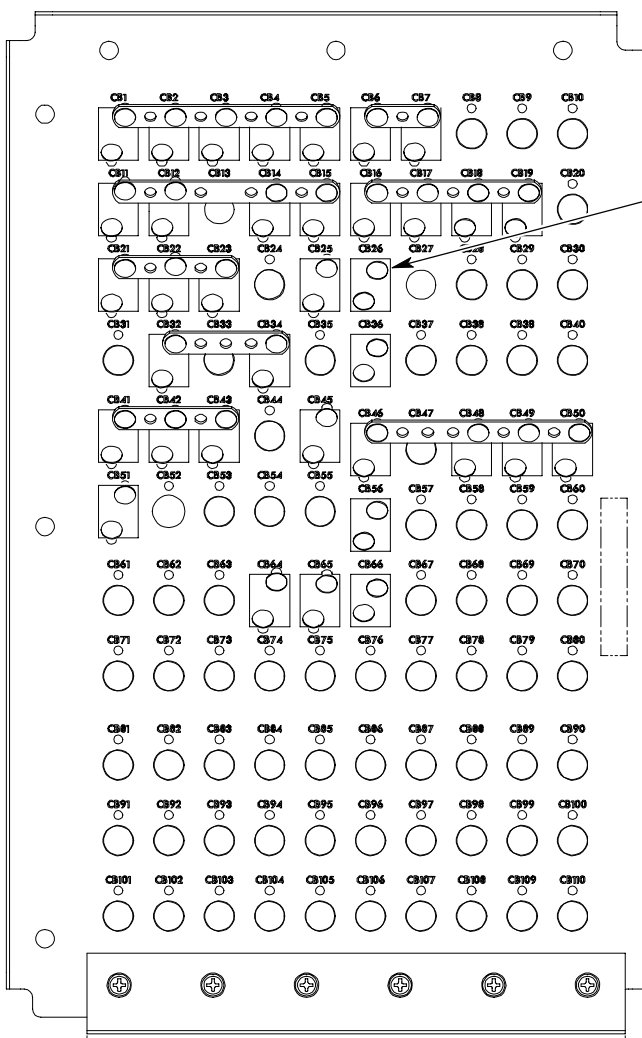
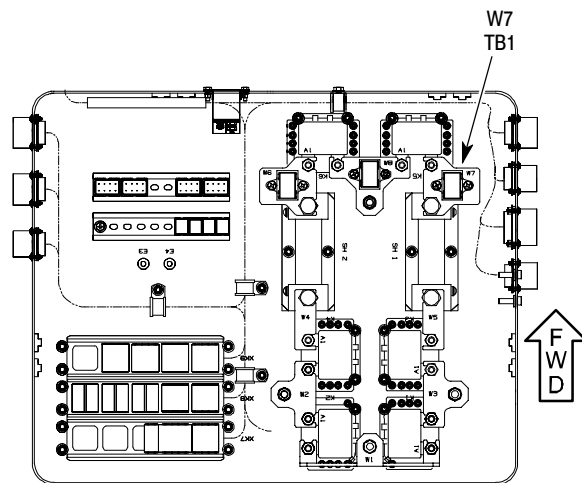
Figure 1. Electrical Load Center Component Locations

A wire which supplies power to the No. 2 condenser fan circuit breaker was inadvertently omitted on some MD-900 helicopters. This wire is considered part of the basic helicopter design and should be present on all MD-900 helicopters.

- (1). Open baggage compartment door L262 (Ref. CSP-RMM-2, Section 06-00-00, Access Methods).
- (2). Remove baggage compartment roof insulation as required to gain access to electrical load center (Ref. CSP-RMM-2, Section 25-50-00, Insulation Panel Removal).
- (3). Open electrical load center, A620 and check for wire segment P113B12 EMI 3 between CB26-1 and W7-TB1-B.
- (4). If wire segment P113B12 EMI 3 is present, perform step 2.C. Completion Instructions.
- (5). If wire segment P113B12 EMI 3 is not present, continue with Rework Instructions below.

- (1). Fabricate and identify wire in accordance with Wire Build Table and Rotorcraft Maintenance Manual (CSP-900RMM-3).

- (3). Install wire P113B12 EMI 3 from CB26-1 to W7-TB1-B.
- (4). Reidentify wire harness 900E2760620-123 to 900E2760620-125 by ink stamping new number on wire harness identification tag.
- (5). Reidentify electrical load center 900E2750620-127 to 900E2750620-129 by ink stamping new number on box.
- (6). Close electrical load center.
- (7). Test air conditioning system, if installed.
 - (a). Start engines (Ref. CSP-902RFM-1, Section IV).
 - (b). Turn on air conditioning (Ref. CSP-902RFM-1, Section X).
 - (c). Verify that CNDSR FAN 1 circuit breaker, CB56 and CNDSR FAN 2 circuit breaker, CB26 are both closed.
 - (d). Open CNDSR FAN 1 circuit breaker, CB56 and verify air flow is present below baggage compartment door, indicating that condenser fan 2 is functioning.
