# SERVICE BULLETIN

DATE: 23 APRIL 2001

## NON-ROTATING SWASHPLATE ASSEMBLY BUSHING REWORK AND LONGITUDINAL DRIVE LINK ASSEMBLY INSPECTION AND REPAIR

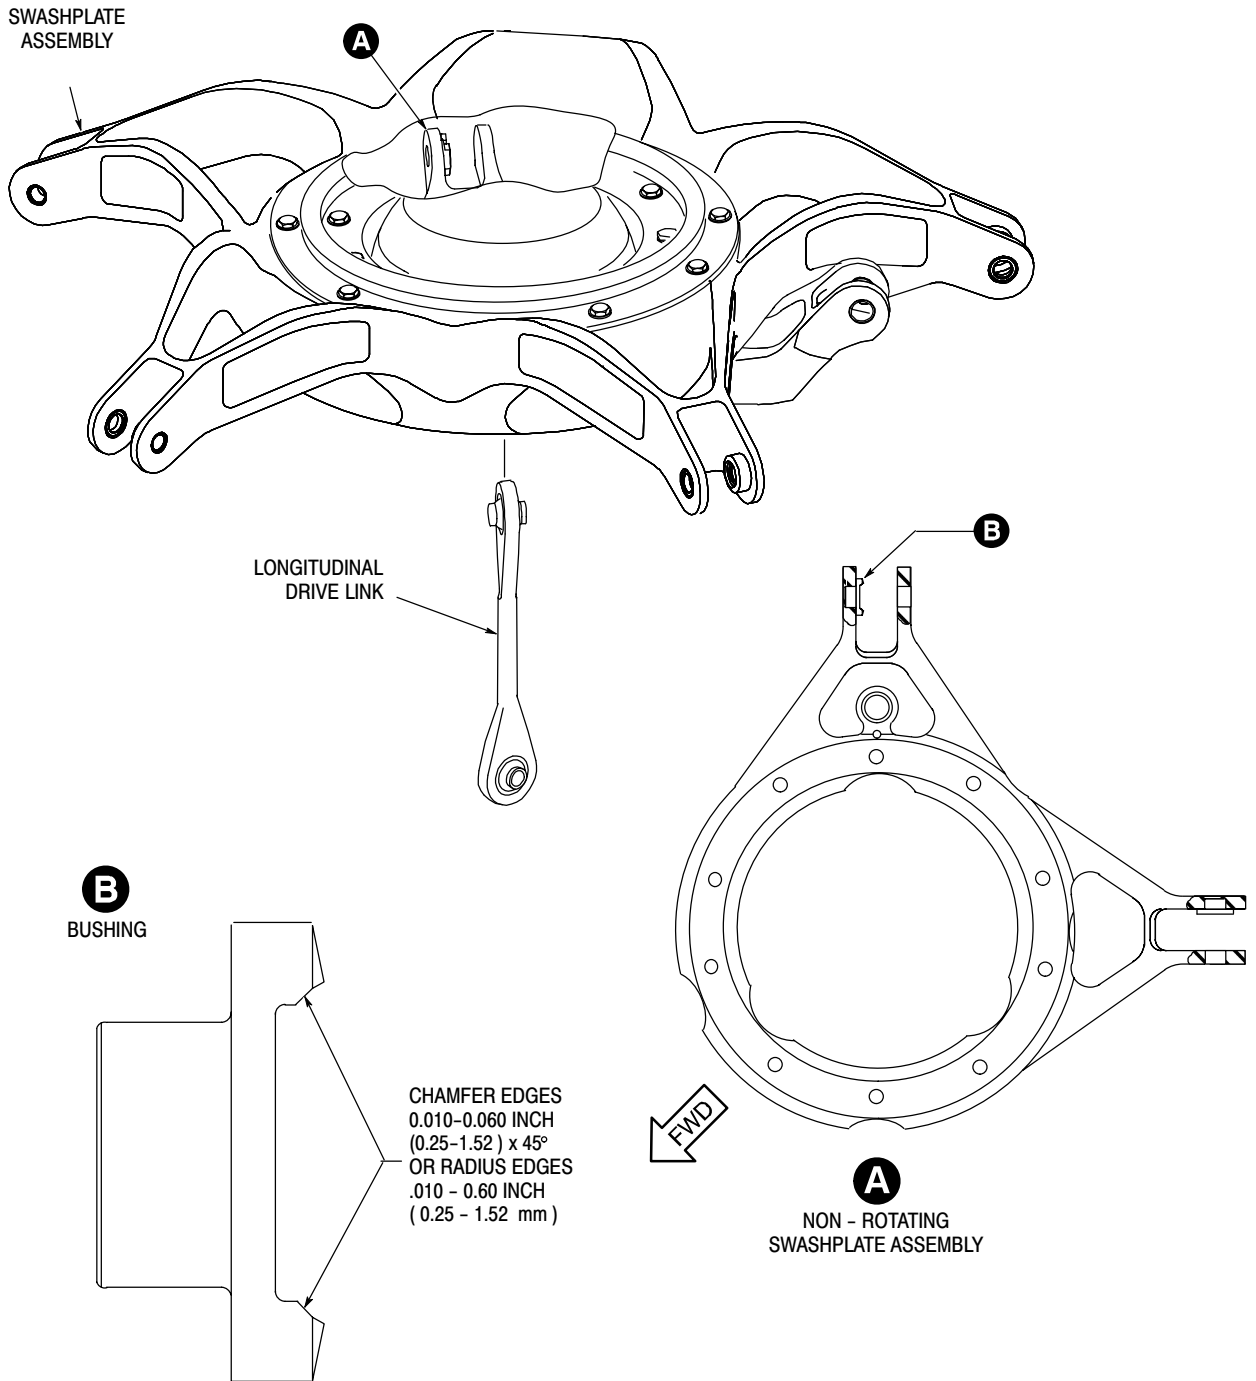
**Figure 1. Swashplate Rework**

There have been reports of damage to the longitudinal drive link assembly caused by the sharp inner edge of the bushing in the non-rotating swashplate assembly. This Bulletin is issued to cover non-rotating swashplate assembly parts not included in Service Bulletin SB900-071.

### **A. Rework non-rotating swashplate assembly:**

(Ref. Figure 1)

- (1). Remove longitudinal drive link assembly per instructions contained in the Rotorcraft Maintenance Manual (CSP-900RMM-2, Section 62-30-00).

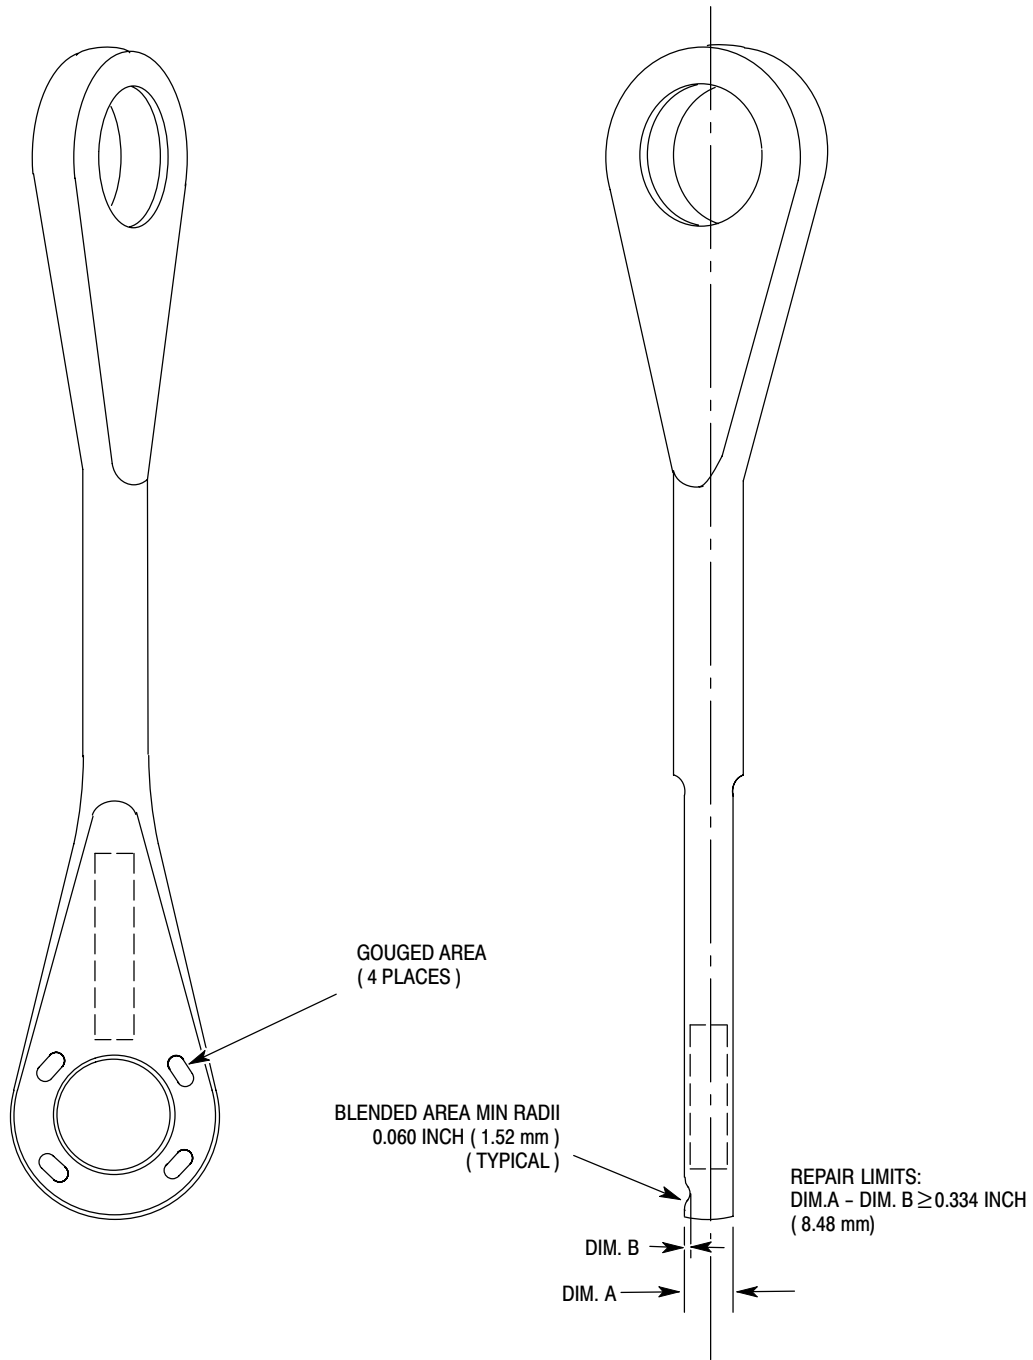
**Figure 2. Repair of Longitudinal Drive Link**

Failure to comply with this Service Bulletin may result in non-repairable damage to the longitudinal drive link and eventual loss of longitudinal control of the helicopter.
