SERVICE BULLETIN

DATE: 15 SEPTEMBER 2006
PAGE 1 OF 6

INTEGRATED INSTRUMENT DISPLAY SYSTEM (IIDS) EEC LIGHT WIRING MODIFICATION

MD900 Helicopters, serial numbers 900-00088 thru 900-00110, 900-00113 and 900-00114.

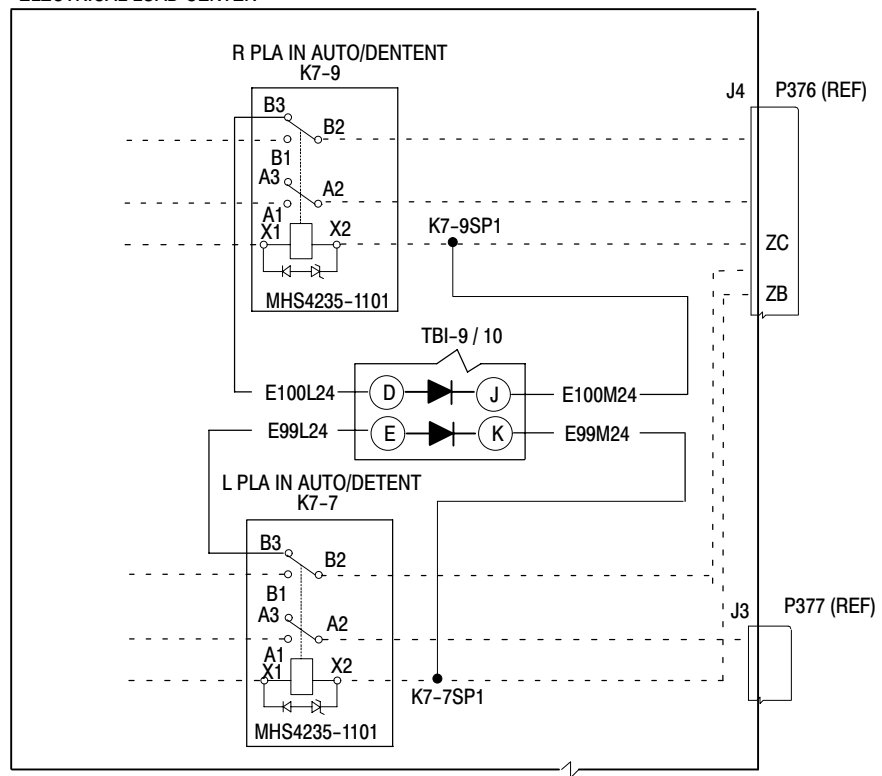
Figure 1. IIDS Signal Correction Modification Wiring Diagram

The IIDS Electronic Engine Control (EEC) lights unintentionally blink when power is supplied by the essential bus. Failure to comply with this Bulletin may result in pilot distraction during dual generator failure emergency procedures.

A. Modification of A620 Electrical Load Center

(Ref. Figure 1)

- (1). Remove A620 left cover and lower circuit breaker panel (Ref. CSP-900RMM-3, Section 96-30-00, Electrical Load Center).
- (2). Locate wire segment between A620 J4-ZB and A620 K7-7 X2.

- (3). Install splice A620 K7-7 SP1 on wire segment within 6 in. (152.4 mm) of A620 K7-7. Insert wire segment from A620 J4-ZB and wire segment from A620 K7-7 X2 into splice prior to crimping.

- (4). Install wire E99M24 EMI 3 from A620 K7-7 SP1 to A620 TB1-9/10 K.
- (5). Locate wire segment between A620 J4-ZC and A620 K7-9 X2.
- (6). Install splice A620 K7-9 SP1 on wire segment within 6 in. (152.4 mm) of A620 K7-9. Insert wire segment from A620 J4-ZC and wire segment from A620 K7-9 X2 into splice prior to crimping.

- (7). Install wire E100M24 EMI 3 from A620 K7-9 SP1 to A620 TB1-9/10 J.
- (8). Install wire E99L24 EMI 3 from A620 K7-7 B3 to A620 TB1-9/10 E.
- (9). Install wire E100L24 EMI 3 from A620 K7-9 B3 to A620 TB1-9/10 D.

- (10). Install sleeving over splices A620 K7-7 SP1 and A620 K7-9 SP1 for chafe protection.
- (11). Tie added wires into A620 assembly electrical load center wire harness W620.
