# SERVICE BULLETIN

DATE: 17 JUNE 2002  
PAGE 1 OF 4

## MODIFIED EMPENNAGE BELLCRANK ASSEMBLY REIDENTIFICATION

MD900 helicopters, serial number 900-00008 thru 900-00106.  
All empennage bellcrank assemblies (P/N 900F2341712-101) in spares inventory.

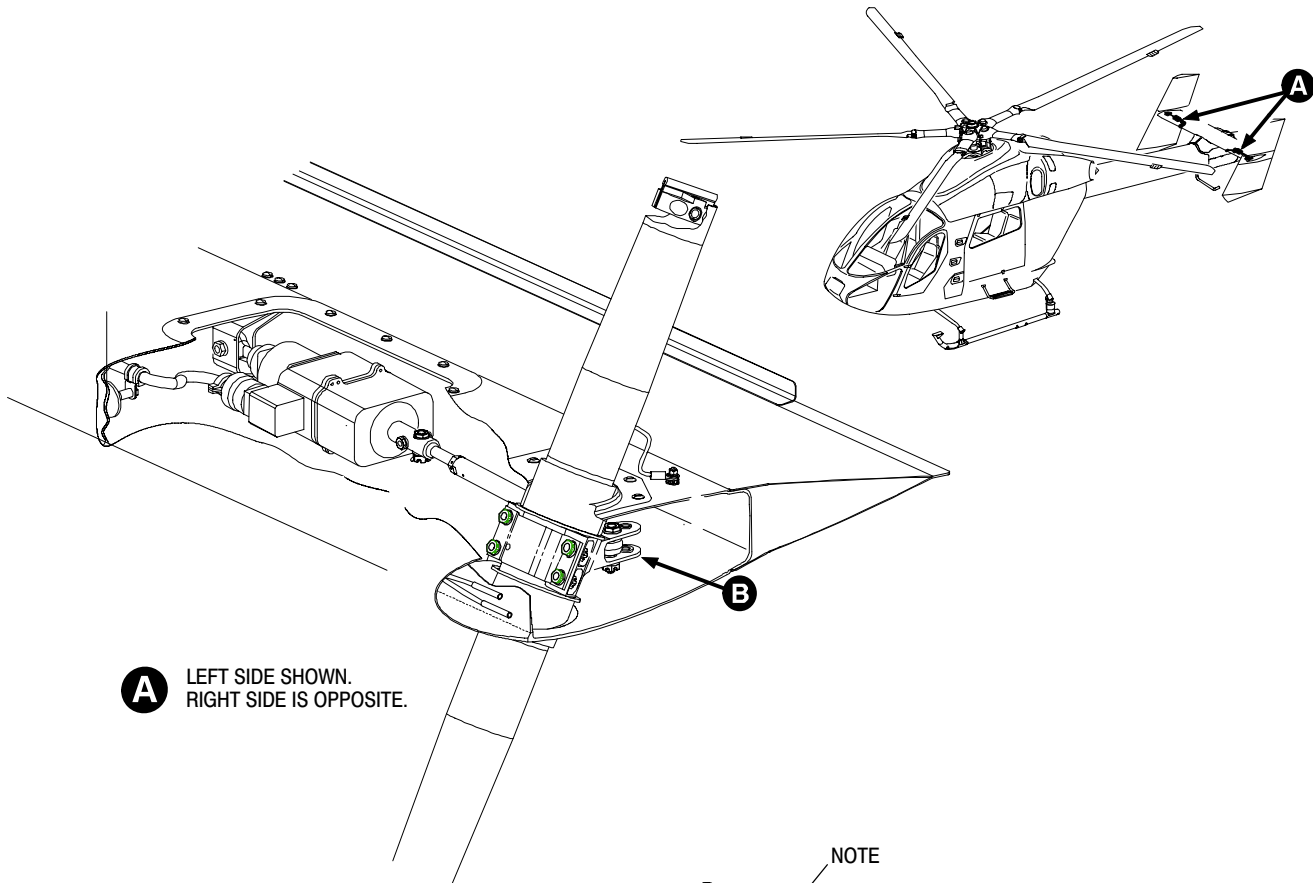
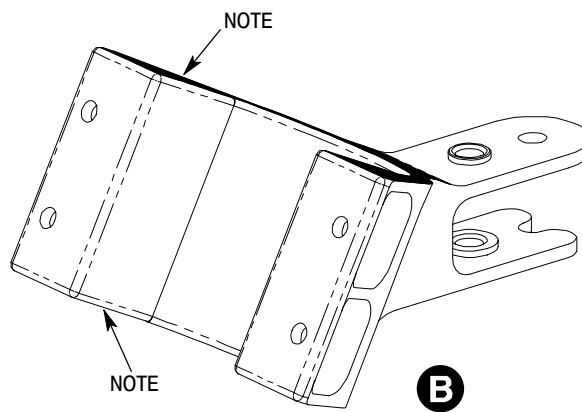
**Figure 1. Empennage Bellcrank Assembly**

Some P/N 900F2341712-101 empennage bellcrank assemblies were modified by adding Karon coating to the upper and lower surfaces but were not reidentified with the new part number (900F6341712-101). The unmodified bellcrank is a life-limited part and the modified bellcrank has an unlimited life.

- (1). Inspect P/N 900F2341712-101 empennage bellcrank assembly for Karon (black) coating on upper and lower surfaces, as shown.
- (2). If bellcrank does not have Karon coating, no further action is required. Return part to spares inventory.
- (3). If bellcrank has Karon coating, perform C. Reidentification Instructions, Steps (1) through (3) below and return part to spares inventory.

- (b). If part number is 900F2341712-101, determine if it has Karon (black) coating on upper and lower surfaces, as shown.
  - 1). If bellcrank does not have Karon coating, no further action is required. Proceed to D. Completion Instructions below.
  - 2). If bellcrank has Karon coating, perform C. Reidentification Instructions below.

NOTE: KARON (BLACK) COATING ON UPPER  
AND LOWER SURFACES OF BELLCRANK

- (1). Line through existing part number (900F2341712-101); do not obscure serial number.

- (2). Permanent ink stamp or mark new part number (900F6341712-101) above lined through part number.
- (3). Cover area with moisture resistant varnish per manufacturer's instructions.
