SERVICE BULLETIN

MAIN ROTOR SUPPORT STATIC MAST, ONE TIME INSPECTION

MD-900 helicopters, serial number 900-00008 thru 900-00110.

Main Rotor Support Static Mast 900F2401021-101.

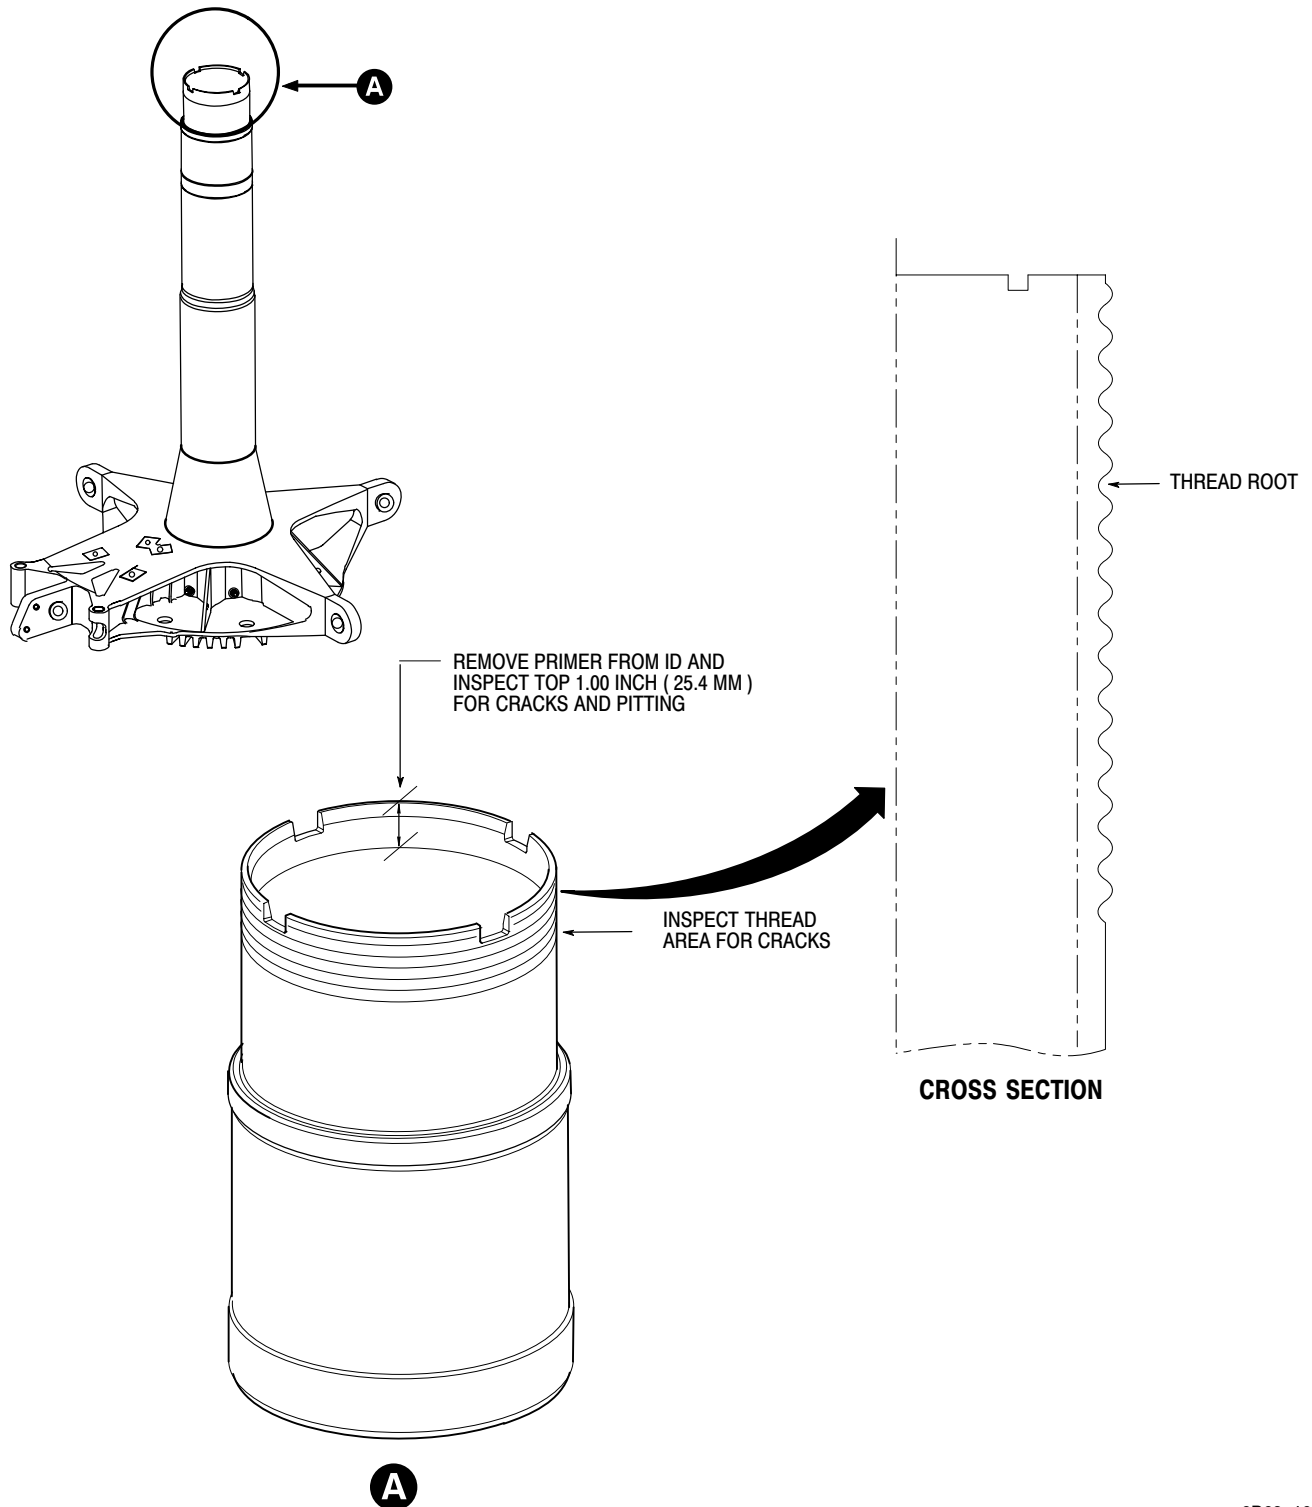
Figure 1. Main Rotor Support Static Mast

Operators have reported a crack in the top of the main rotor support static mast. Information obtained since SB900-089 was released indicates it is possible that cracks may be present in the outside diameter (OD) without showing on the inside diameter (ID). Failure to comply with instructions in this bulletin could result in loss of main rotor system.

- (3). Inspect top inside diameter (ID) of static mast for cracks and pitting.

- (b). Inspect top 1 inch (25.4 mm) of inside of mast (entire circumference) for evidence of cracks or pitting using bright light and 10x magnification. If there is a crack, the main rotor support static mast must be removed from service. If there is evidence of pitting or other anomaly, contact MDHI Field Service Department for repair disposition before further flight.

- (4). Remove main rotor hub assembly. (Ref CSP-900RMM-2, Section 62-20-00, Main Rotor Hub Assembly Removal.)
- (5). Clean threads thoroughly with solvent. Inspect static mast threads for cracks using bright light and 20x magnification. Pay particular attention to thread root area. If defects or suspect cracks in thread area are found, perform magnetic particle inspection (wet fluorescent) per ASTM E 1444-01 using electromagnetic yoke or coil. If there is a crack, the main rotor support static mast must be removed from service.

- (6). If there is no evidence of cracks or pitting in mast, reapply primer to mast ID and reassemble main rotor drive shaft and hub assemblies (Ref CSP-900RMM-2) and return to service. Perform Main Rotor Drive Plate Nut Torque Verification (Ref CSP-900RMM-2, Section 05-20-10, Special Inspection - After Component Installation.)
