SERVICE BULLETIN

MAIN ROTOR BLADE RETENTION BOLT INSPECTION

MD900 helicopters, serial number 900-00008 thru 900-00114.

DATE: 2 SEPTEMBER 2004
 PAGE 2 OF 8

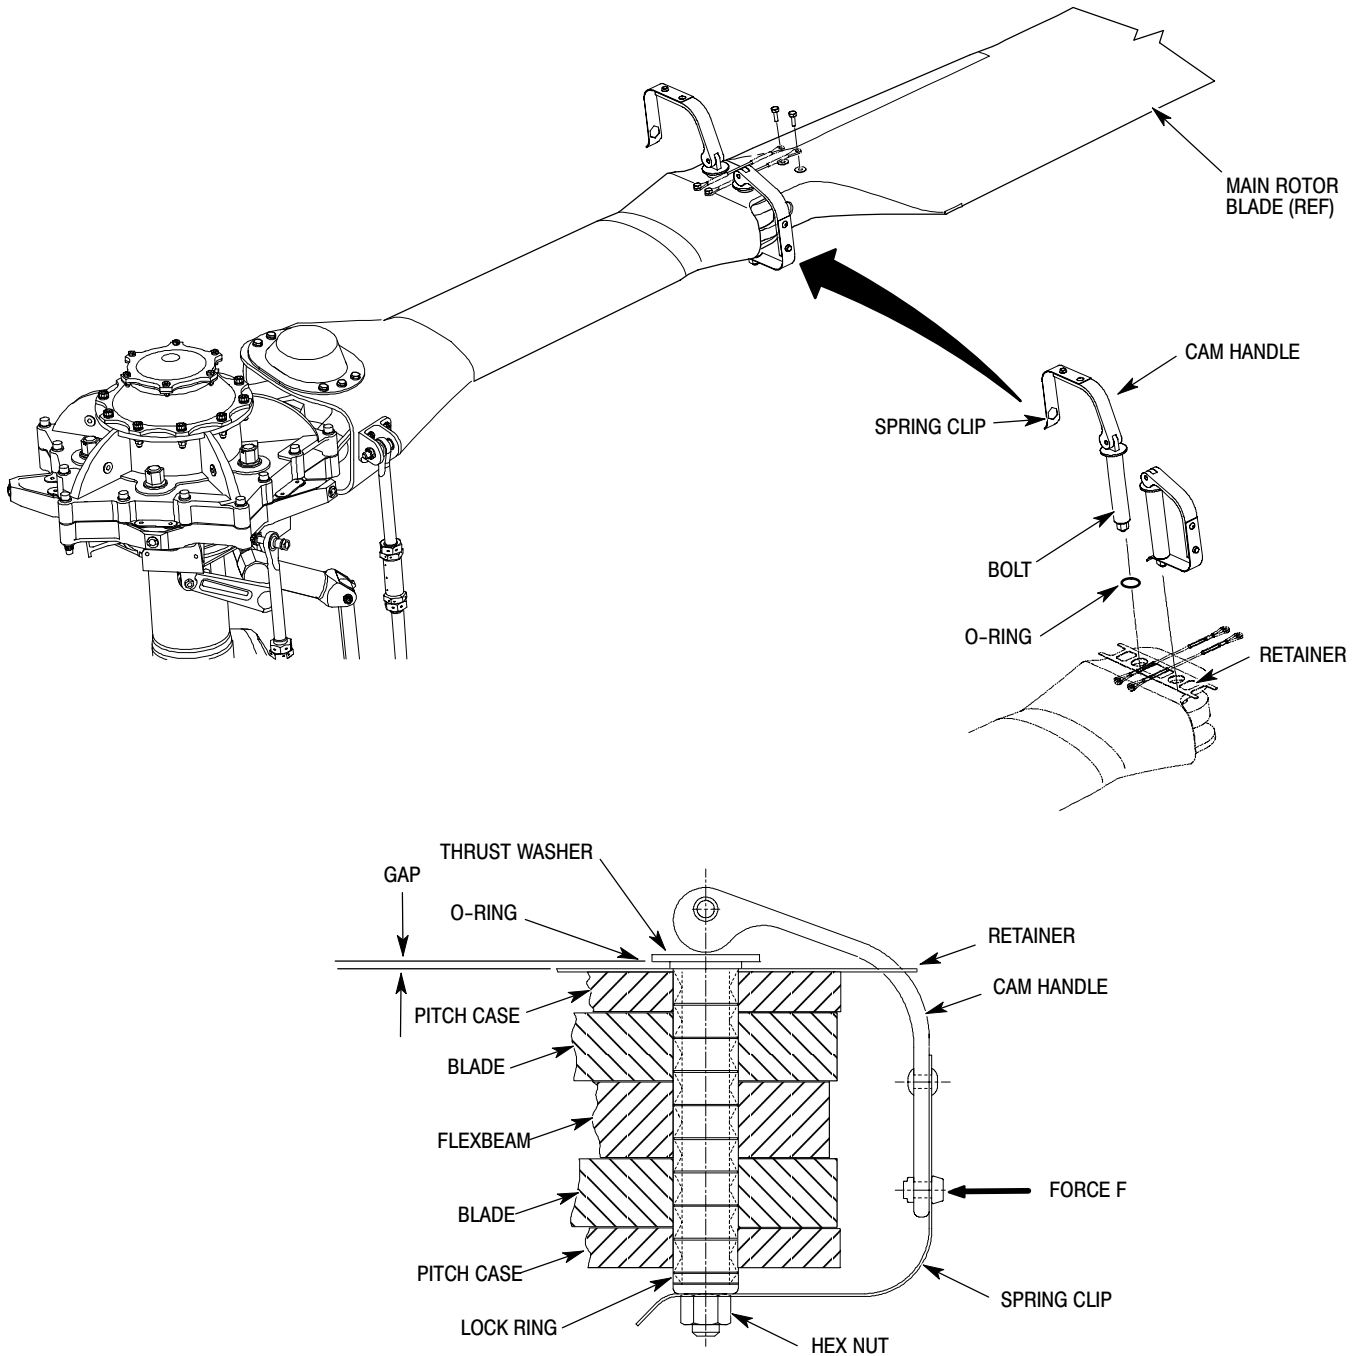
Figure 1. Blade Retention Bolt

- (1). Check that position of installed blade retention bolts have not shifted upward.
- (2). Visually inspect installed blade retention bolts for gap between thrust washer and retainer.
- (3). If any blade retention bolt has shifted position upward or there is no gap between thrust washer and retainer, accomplish Part 2 of this Bulletin prior to flight.

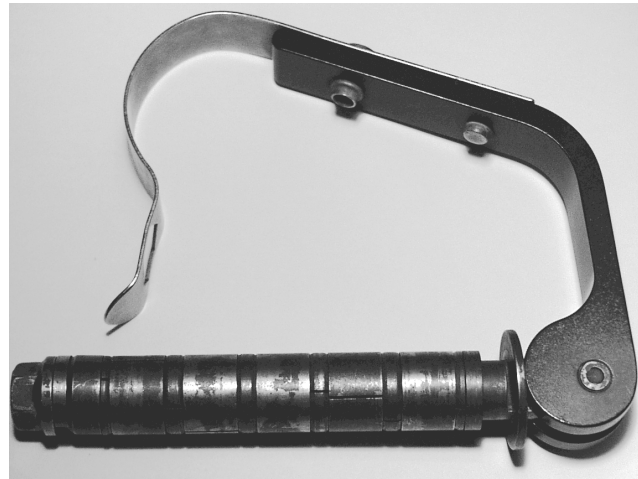
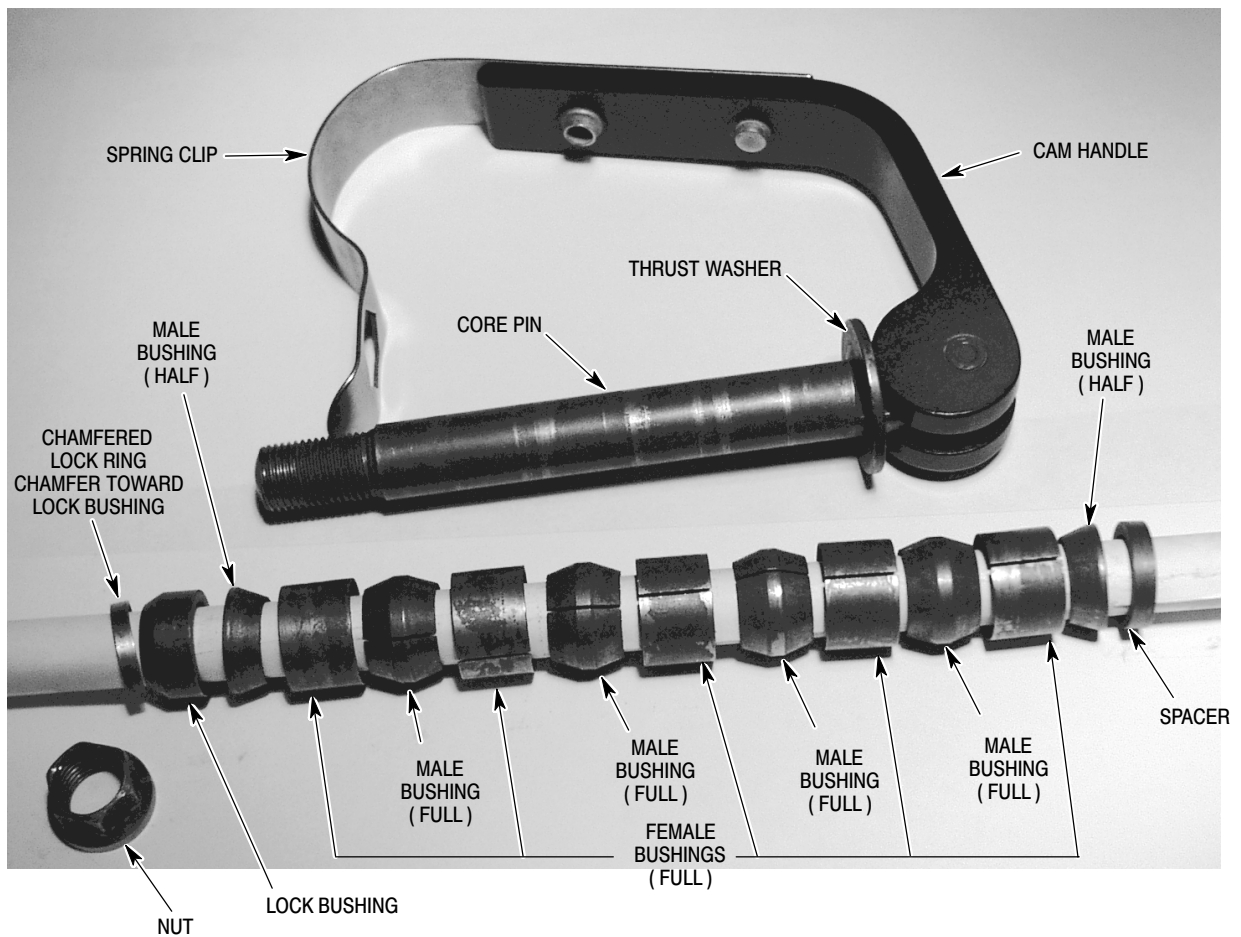
Figure 2. Disassembled Blade Retention Bolt Inspection

- (b). Using 5x magnification, inspect core bolt for damage. None allowed, except for minor scratches or score marks that do not penetrate machined surface finish.

- (c). Visually inspect nut and core bolt threads. No damage allowed that interferes with normal assembly.
 - (d). Visually inspect expanding elements and spacers. No cracks allowed.

- (4). Disassemble each blade retention bolt.

- (a). Carefully remove weld spot in lead thread. Use extreme caution to avoid damage to threads.
- (b). Chase threads using an appropriate tool. Thread on the core bolt is 0.5000-20 UNJF-3A per MIL-S-8879.
- (c). Remove nut from bolt and retain for reuse.

- (d). Remove expanding elements, taking great care to keep them in order and maintain installation orientation.
- (5). Inspect each retention bolt.
 - (a). Clean bolt with isopropyl alcohol. Do not remove dry-film lubricant.

- (e). If all examinations are acceptable, as required touch-up dry-film lubricant (aerosol) on core bolt to a thickness of 0.001 inch (0.0254mm) maximum. Cure per manufacturers instructions.

- (6). Reassemble acceptable blade retention bolts.
 - (a). Reassemble expanding elements onto core bolt, taking great care to ensure that they are in the same location and orientation as when removed.

- (b). Reinstall nut. Measure drag/locking torque (should be **14 - 100 in-lb (1.6 - 11.2 N•m)**). If outside locking torque limits, replace nut.
