Revised Thruster Modification Cut Out Dimension

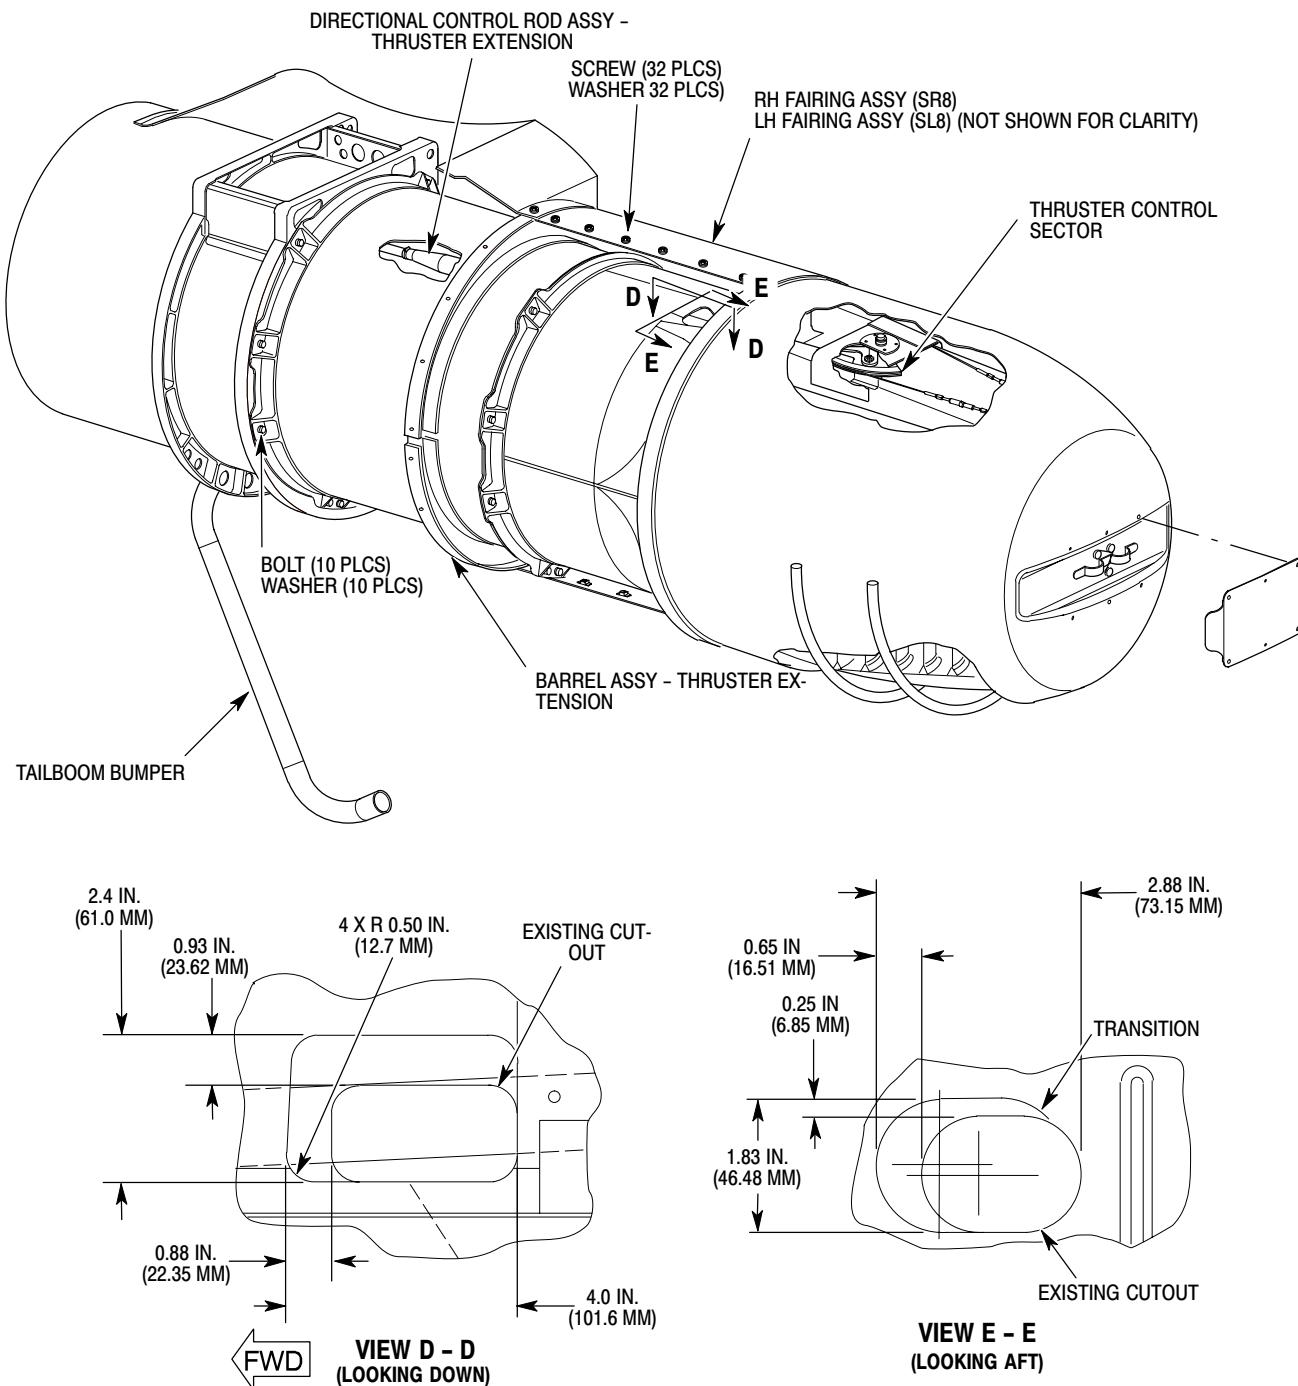
Figure 1. Thruster Modification

MD Helicopters, Inc. (MDHI) has found that on some aircraft the thruster cut out dimension published in SB900-099 is not sufficient to give clearance for the thruster control rod. To make sure there is correct clearance, use the cut out dimension that is shown in Figure 1.
