SERVICE BULLETIN

DATE: 27 DECEMBER 2006
PAGE 1 OF 8

THRUSTER EXTENSION AND VORTEX GENERATOR INSTALLATION

Service Bulletin SB900-099R1, Thruster Extension and Vortex Generator Installation

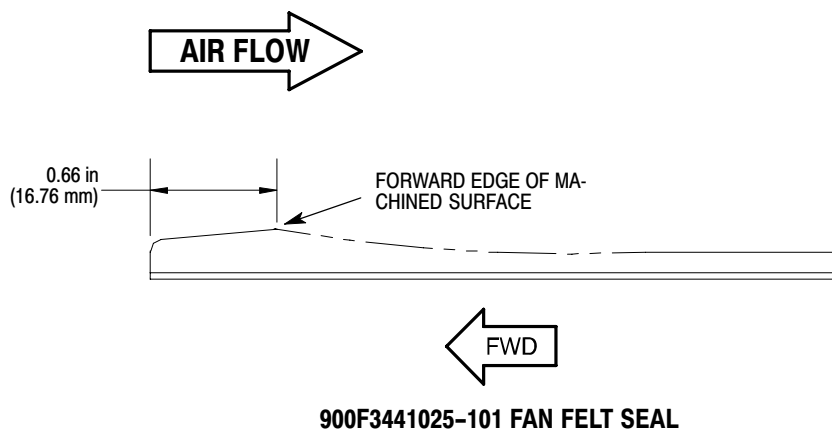
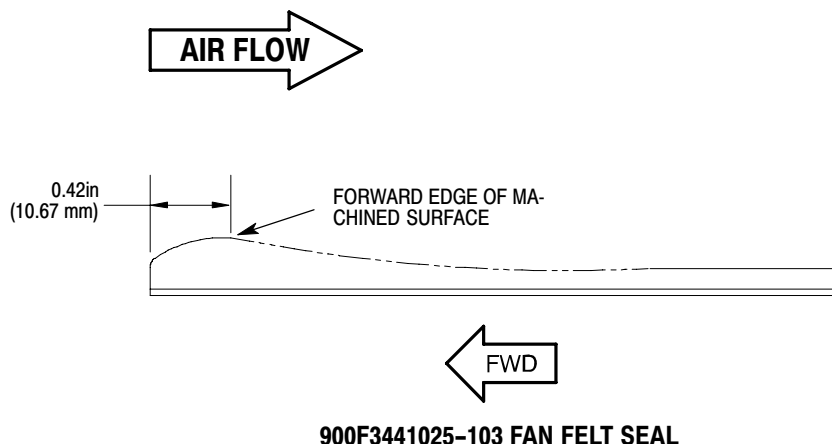
Figure 1. Fan Felt Seal Identification

- (1). Verify that P/N 900F3441025-103 NOTAR® Fan Liner (Felt Metal Seal) is installed.
(Ref. Figure 1)
 - (a). If necessary, replace with a P/N 900F3441025-103 Fan Liner (Felt Metal Seal) (Ref. CSP-900RMM-2, Section 64-30-00).

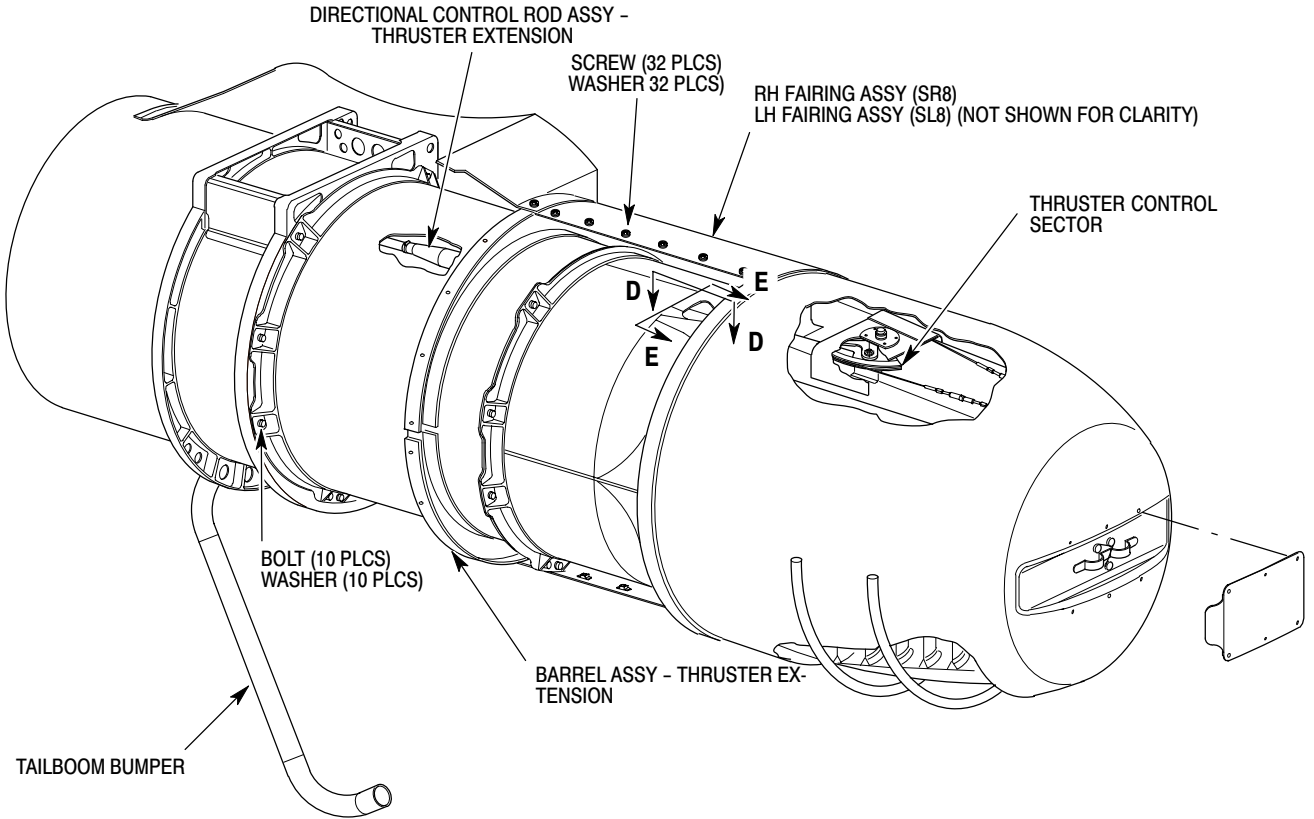
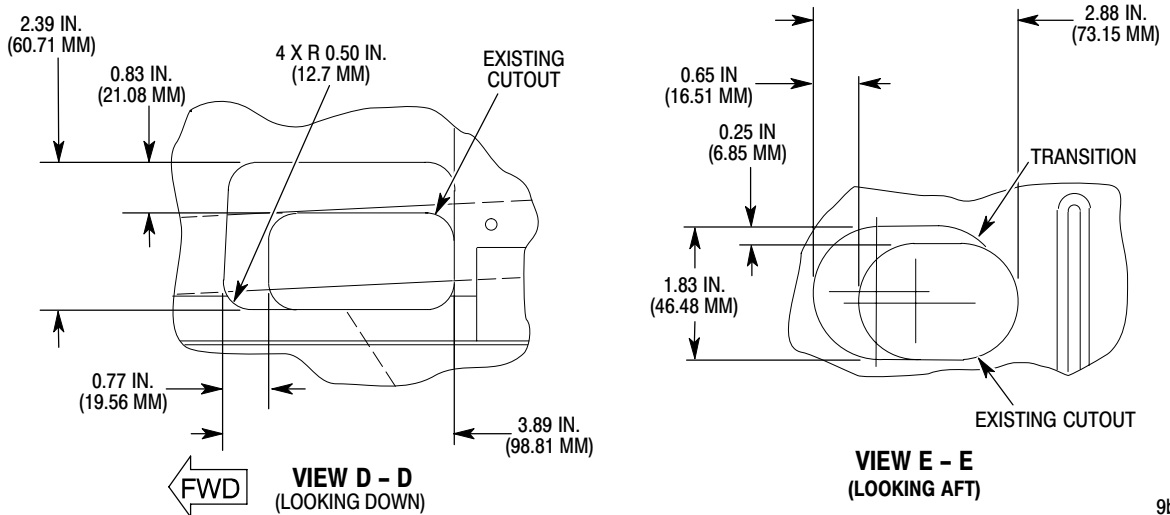
Figure 2. Thruster Extension Modification

(8). Modify thruster assembly.

- (a). Trim thruster control rod pass thru hole per View D-D and View E-E and seal any exposed fibers with Epoxy Resin, refer to resin manufacturer's instructions.
- (b). Verify that installed thruster control sector assembly is PN 900C2010392-109. If the PN is not correct, contact MDHI Field Service Department.
- (c). Using permanent ink, reidentify modified thruster assembly, at location of existing part number, as PN 90005310000-101.
