SERVICE BULLETIN

* Supersedes Service Bulletin SB900-116, dated 24 February 2010. Revised to change the inspection interval for the blade retention bolt force and torque check following the first flight after installation from 4 to 6 flight-hours to 8 to 10 flight-hours; and to revise the change of force or torque from not more than 10 percent to not more than ± 10 percent.

300-HOUR INSPECTION FOR THE MAIN ROTOR BLADE RETENTION BOLTS

All MD900 helicopters with 900R3100001-103 and 900R3100001-105 blade retention bolts installed.

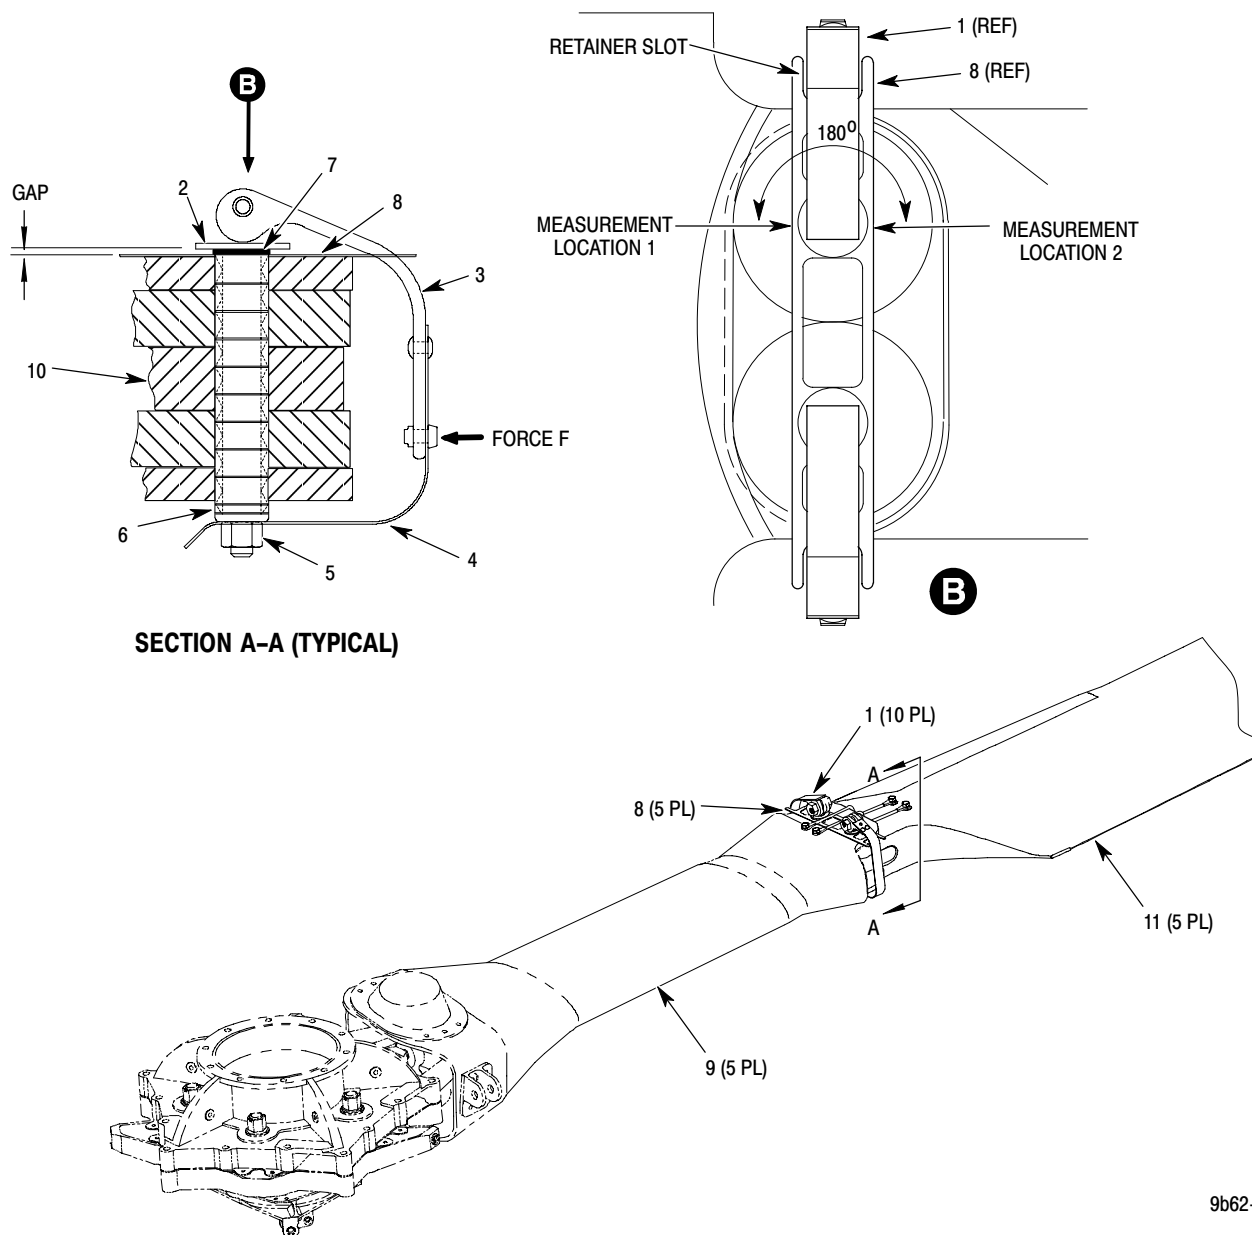
Figure 1. Gap and Force Check of the Blade Retention Bolts

- (1). Visually examine blade retention bolts (1) for a gap between thrust washer (2, 4) and retainer (8, 9). (Ref. Figure 1 and Figure 2.)
 - (a). Make sure O-ring (7) is installed.

- (2). Measure the gap at two locations, 180 degrees apart, with a feeler gage.
 - (a). If the gap is more than **0.100 inch (2.54 mm)** remove blade retention bolt (1) (ref. CSP-900RMM-2, 62-10-00, Main Rotor Blade Removal/Installation).

- (5). Do a check of Force F with a push/pull spring scale.

- (a). If Force F has changed by more than ± 10 percent of the recorded final installation force, turn hex nut (5) until the Force F required to close cam handle (3) is **65 to 115 lbf (29.48 to 52.16 kgf)**.
- (b). If necessary, turn hex nut (5), in the tightening direction only, to align the nut with the hex-shaped hole of spring clip (4) without a recheck of Force F.

- 1). Install missing O-rings (ref. CSP-900RMM-2, 62-10-00, Main Rotor Blade Removal/Installation).
 - (b). If there is a gap go to Step (2).
 - (c). If there is no gap, remove blade retention bolt (1) (ref. CSP-900RMM-2, 62-10-00, Main Rotor Blade Removal/Installation).

- 1). Visually examine the assembled bolt for damage.
 - 2). Re-install an undamaged bolt (ref. CSP-900RMM-2, 62-10-00, Main Rotor Blade Removal/Installation).

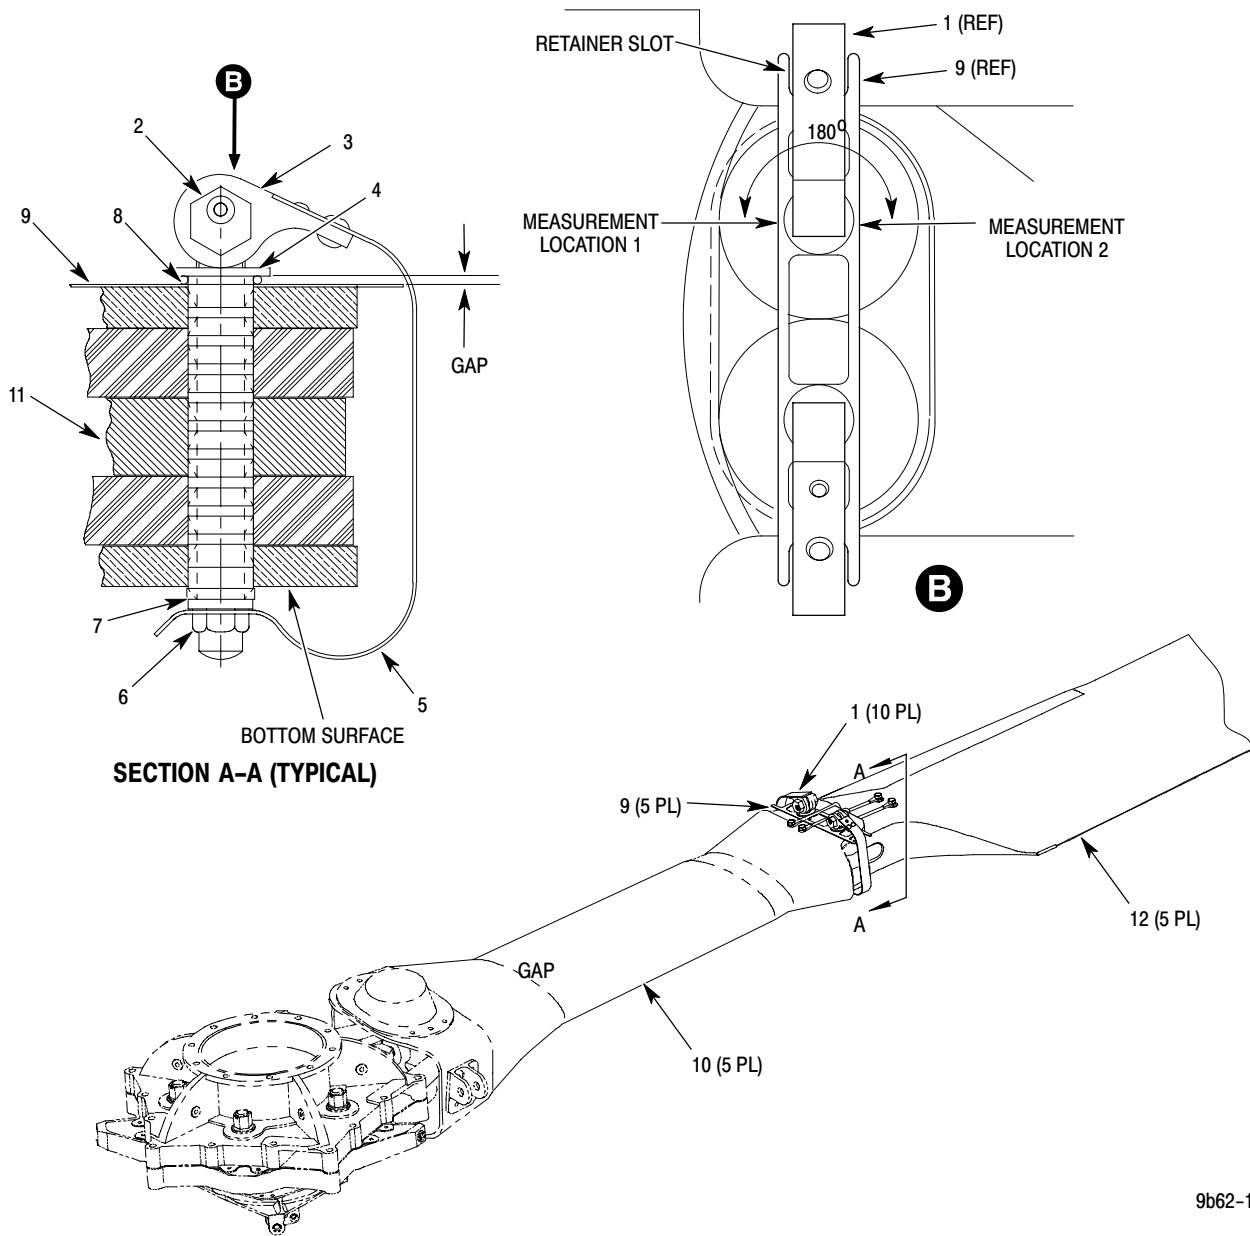
Figure 2. Gap and Torque Check of the Blade Retention Bolts

(5). Do a torque check of torque nut (2).

(a). If the torque has changed by more than ± 10 percent of the recorded final installation torque (ref. CSP-900RMM-2, 62-10-00, Main Rotor Blade Removal/Installation), turn torque nut (2) until the torque required to close spring clip (5) is **350 to 450 in-lb (39.5 to 50.8 Nm)**.

(10). Make sure the gap between thrust washer (4) and retainer (9) is not more than **0.100 inch (2.54 mm)**.
