SERVICE BULLETIN

Eddy Current Inspection of the Main Rotor Lower Hub Assembly

MD900 helicopters, serial numbers (SNs) 900-00008 thru 900-00139, and all spares.

Main Rotor Lower Hub Assembly, Part Number (PN) 900R2101008-107, identified with SNs that begin with 5009.

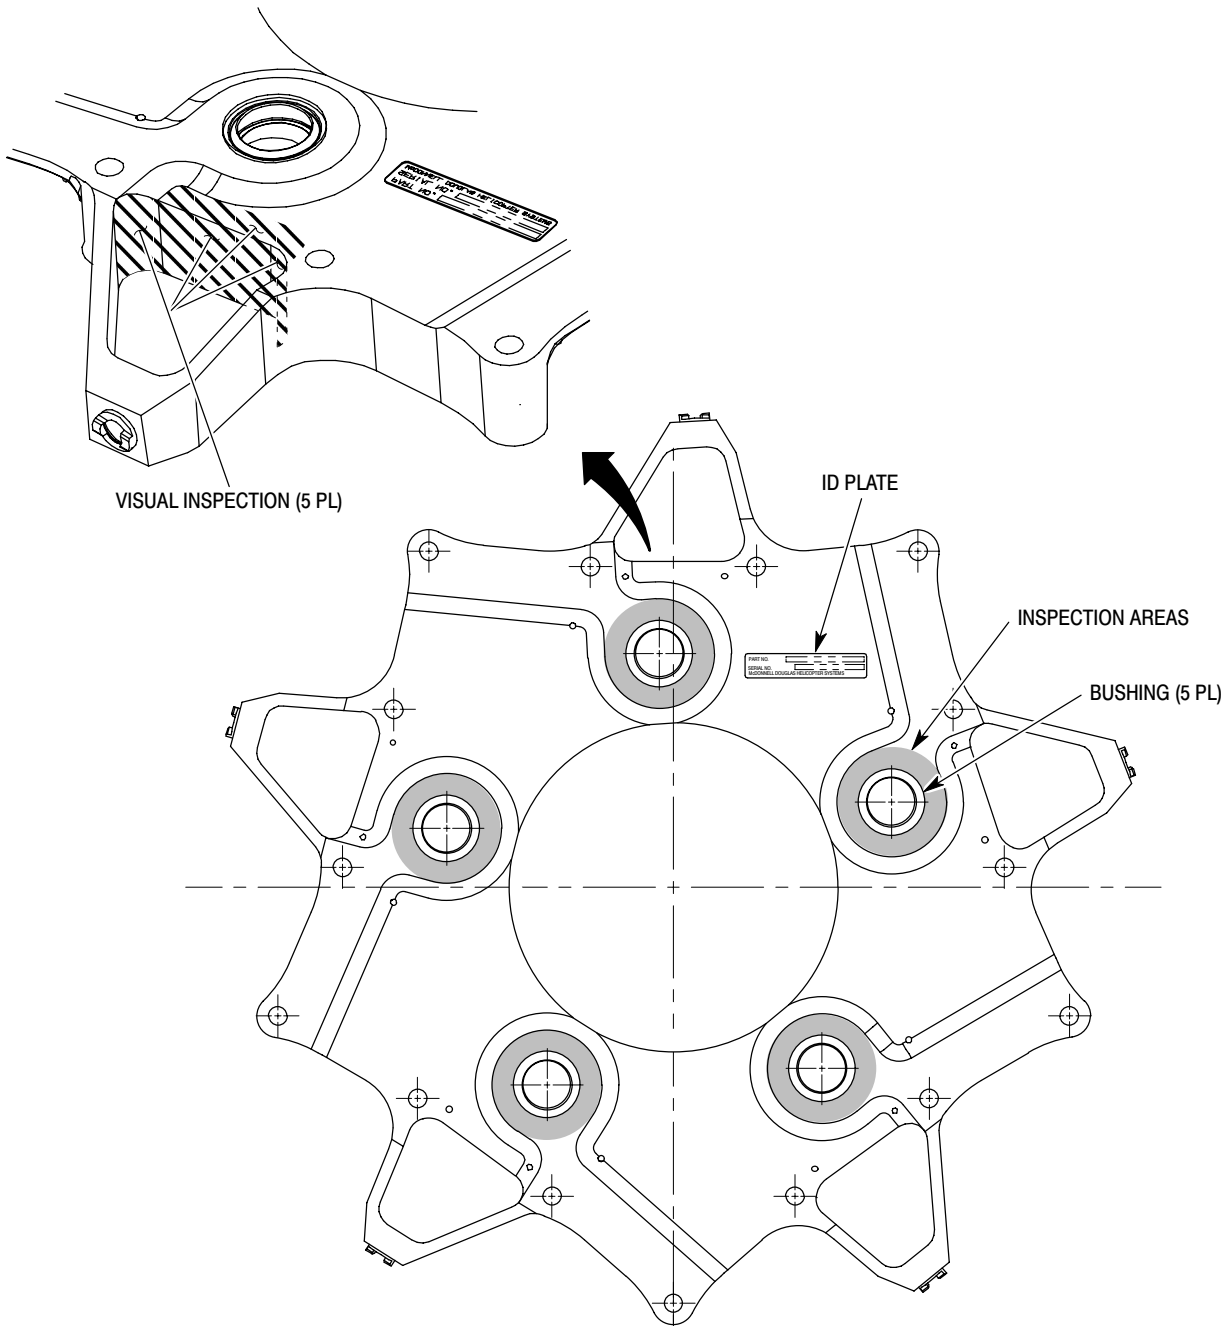
Figure 1. Inspection of the Lower Hub Assembly (Bottom View)

Cracks have been found on four main rotor lower hub assemblies.

- (1). Do a visual inspection of the sides and bottoms of the area between the arms for the centering bearing and the inspection areas adjacent to the bushings for cracks.

(5). Scan all of the inspection area shown by shadow adjacent to the bushings.

(7). Responses more than that of the calibration standard, which are not caused by lift-off, are a cause for rejection.

(11). If there is a crack, remove the lower hub assembly and replace it with an airworthy lower hub assembly.
