TECHNICAL BULLETIN

DATE: 11 NOVEMBER 1997
PAGE 1 OF 6

VSCS ACTUATOR MOUNTING BRACKET REPAIR

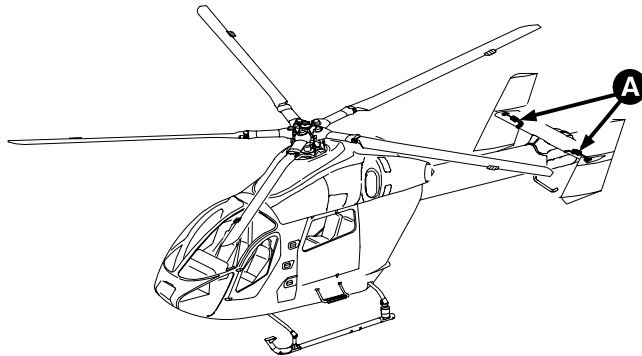
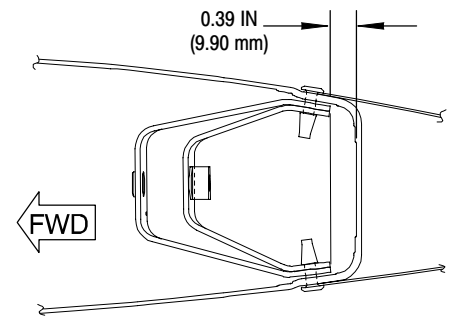
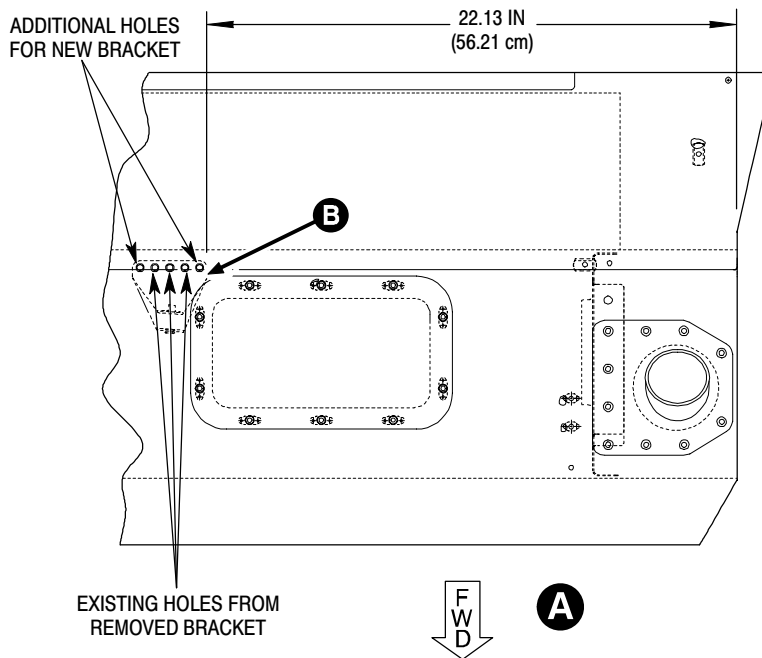
Figure 1. VSCS Actuator Attach Bracket Replacement

Aircraft in the field have experienced working of the VSCS actuator attach bracket attachment fasteners. Failure to repair this condition could result in the loss of control of the horizontal endplates on that side.

Procedures in this Bulletin provide owners and operators with instructions to replace their existing six (6) fastener VSCS actuator attach bracket part number 900F2341255-101 with an improved ten (10) fastener attach bracket part number 900F2341255-103, -104.

(1). Remove VSCS from inboard attach bracket (Ref. CSP-900RMM-2 Section 67-20-00).

(2). Remove existing VSCS actuator bracket.

- (3). Using new bracket locate bracket mounting holes in horizontal stabilizer assembly.

- (4). Drill additional mounting rivet holes to a number 19 drill.
(5). Position bracket in horizontal stabilizer assembly.

- (6). Install fasteners into horizontal stabilizer assembly and bracket. Wet install fasteners using primer MIL-P-23377.
(7). Connect VSCS actuator to new VSCS bracket (Ref. CSP-900RMM-2 Section 67-20-00).
(8). Perform a VSCS Operational Test (Ref. CSP-900RMM-2 Section 67-20-00).
(9). Record compliance to this Technical Bulletin in the Compliance Record section of the helicopter Log Book.
