TECHNICAL BULLETIN

DATE: 12 JANUARY 1998

HEAT/DEFOG UPPER DECK THROUGH FITTING MODIFICATION

MD900 helicopters, serial number 900-00002 thru 900-00051.

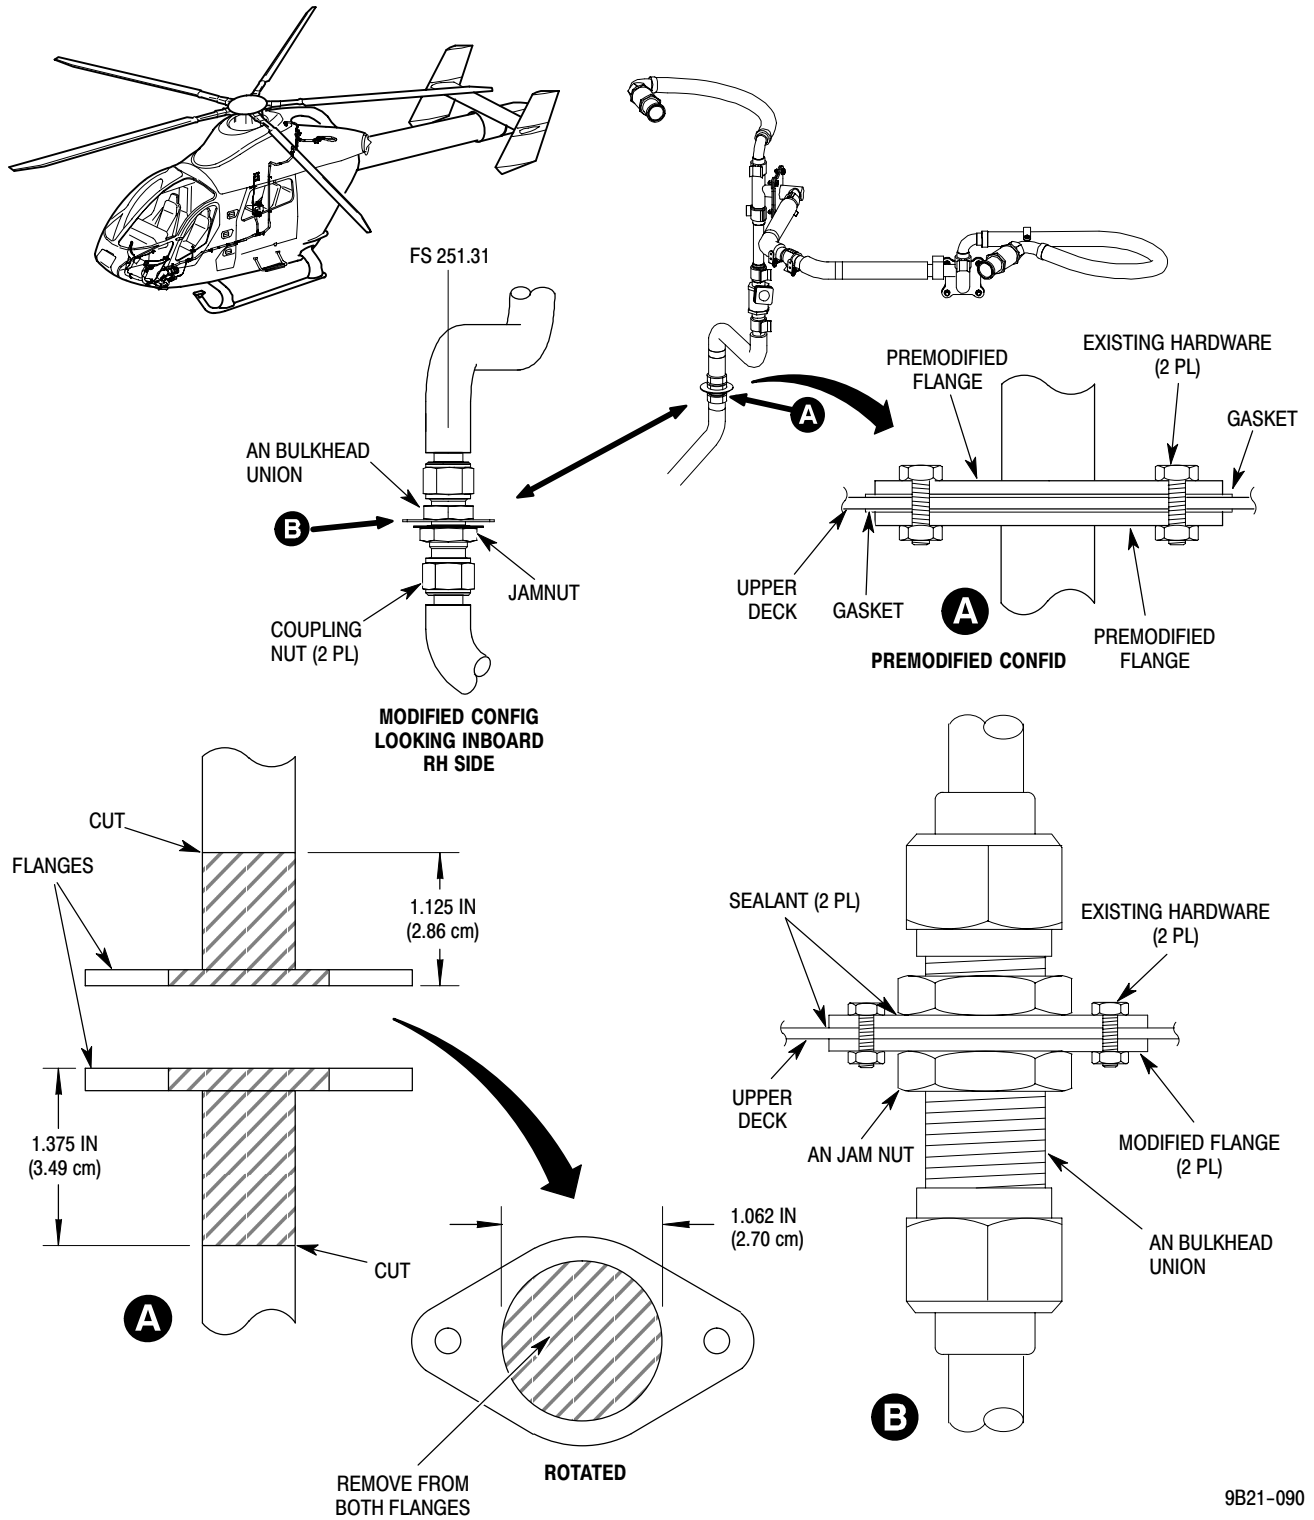
Figure 1. Heat/Defog Modification

Aircraft in the field have experienced bleed air leaks at the upper deck heat/defog through fitting. This causes loss of heating efficiency and failure to pass the heat/defog leak test.

Procedures in this Bulletin provide owners and operators with instructions to replace their existing bleed air through fitting with an AN flared bulkhead union and jam nut. This modification requires flaring of the ends of the affected line and tube assemblies.

- (1). Access heat/defog system at FS 251.31 above and below the upper deck (Ref. CSP-900RMM-2, Section 21-40-00).
- (2). Remove 900P2250205 line assembly and 900P2250209 tube assembly (Ref. CSP-900RMM-2, Section 21-40-00).
- (3). Remove seal assemblies from ends of tube and line assemblies and discard.
- (4). Remove gaskets from above and below upper deck and discard.
- (5). Measure and mark the 900P2250205 line assembly **1.125 in. (2.86 cm)** from flange end.
- (6). Measure and mark the 900P2250209 tube assembly **1.375 in. (3.49 cm)** from flange end.

- (7). Cut the line and tube assemblies at the marks, and deburr.
- (8). Install one (1) each sleeve and coupling nut on each cut tube, and flare in accordance with MS33584 for **0.75 in. (19.05 mm)** tube.

- (10). Modify both removed flanges by removing all remaining tubing.
- (11). Enlarge hole in both flanges to **1.062 in. (2.70 cm)** in diameter and deburr.
- (12). Clean both sides of upper deck and both modified flanges with Desoclean 45 or equivalent and blow dry with filtered compressed air.

- (13). Reinstall flanges wet with fireproof sealing compound and original hardware. Torque bolts **36-46 in. lb. (4.0-5.2 N•m)**.
- (14). Clean AN bulkhead union and jam nut with Desoclean 45 or equivalent and blow dry with filtered compressed air.

- (15). Install bulkhead union through flanges, coat upper threads with thread locking compound and install jam nut. Torque jam nut **500-600 in. lb. (56.48-67.77 N•m)**.

- (18). Reinstall modified line and tube assemblies (Ref. CSP-900RMM-2, Section 21-40-00). Torque coupling nuts **500-600 in. lb. (56.48-67.77 N•m)**.
- (19). Perform Heat/Defog System Leak Check (Ref. CSP-900RMM-2, Section 21-40-00).
