# TECHNICAL BULLETIN

DATE: 27 JANUARY 2003  
PAGE 1 OF 3

## OIL COOLING INLET DUCT MODIFICATION

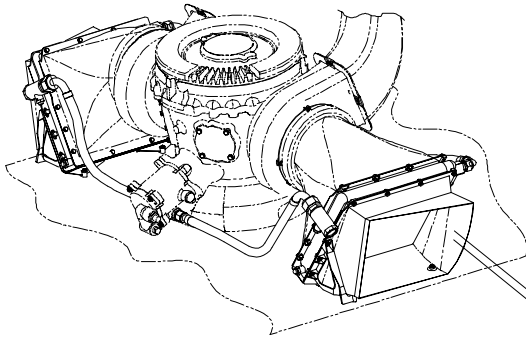
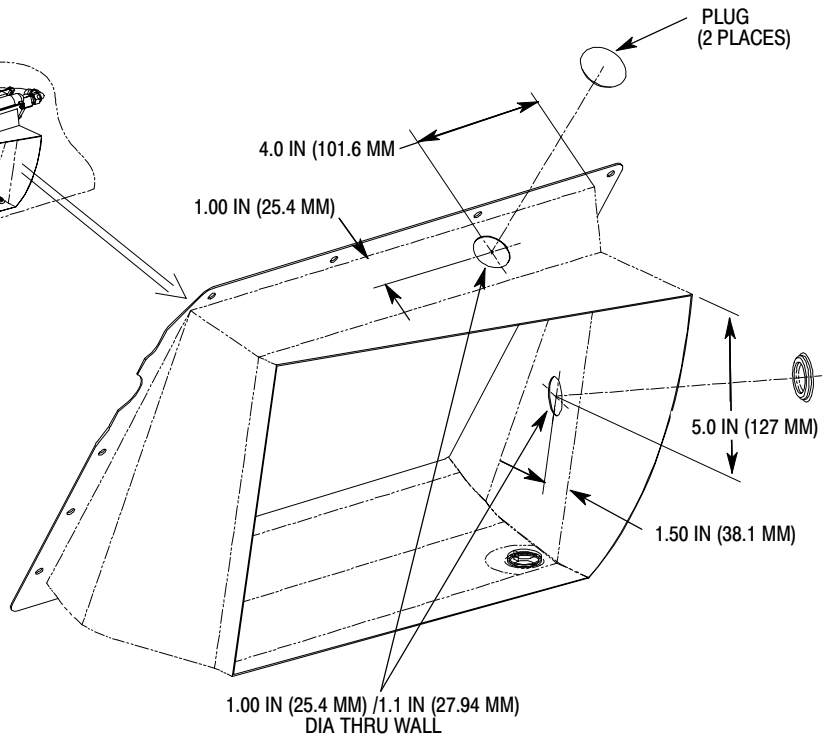
**Figure 1. Oil Cooling Duct Access Holes**

**WITHOUT ROOF MOUNTED AIR CONDITIONING**  
900D3658050-101, -105 LH INLET DUCT SHOWN  
900D3658060-101, -105 RH INLET DUCT OPPOSITE

- (1). Remove forward fairing support assemblies (Ref. CSP-900RMM-2, Section 53-30-00, Forward Fairing Support Assembly Removal).  
(Ref. Figure 1)
- (2). Support inboard wall of duct using wood at hole locations. Wood piece should be clamped firmly and be thick enough for adequate support.
- (3). Cut holes using 1.0 inch (25.4 mm) wood working hole saw.
- (4). Remove wood support and use #120 sandpaper to deburr holes. Using sandpaper, open holes as required to allow for plugs to fit.
- (5). Remove all debris and install plugs in holes.
- (6). Install forward fairing support assemblies (Ref. CSP-900RMM-2, Section 53-30-00, Forward Fairing Support Assembly Installation).

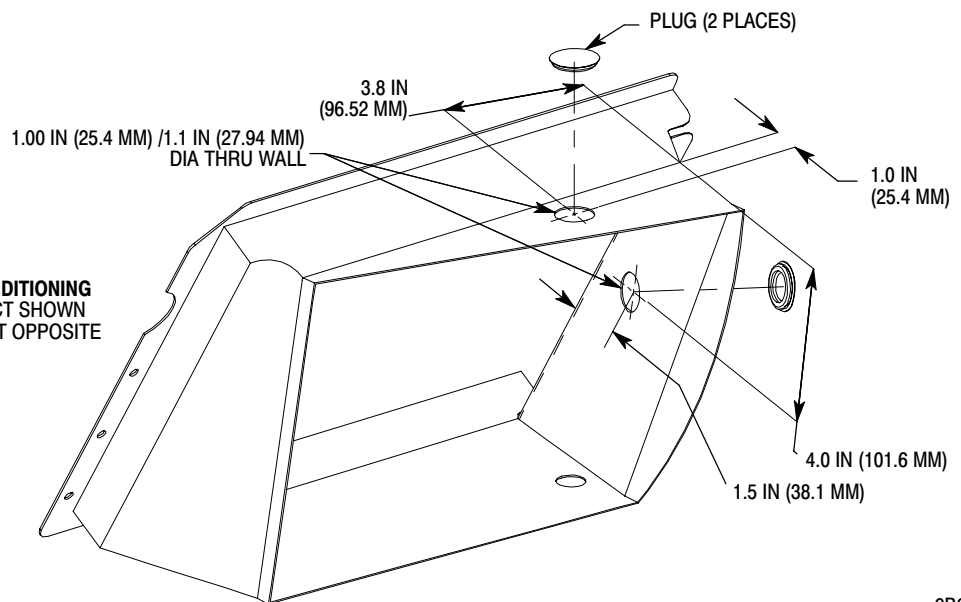
**WITH ROOF MOUNTED AIR CONDITIONING**  
900P2250348-101 LH INLET DUCT SHOWN  
900P2250348-102 RH INLET DUCT OPPOSITE
