TECHNICAL BULLETIN

DATE: 06 MARCH 2008

ELECTRICAL NOISE SUPPRESSION MODIFICATION

Technical Bulletin TB900-027R1, Electrical Noise Suppression Modification

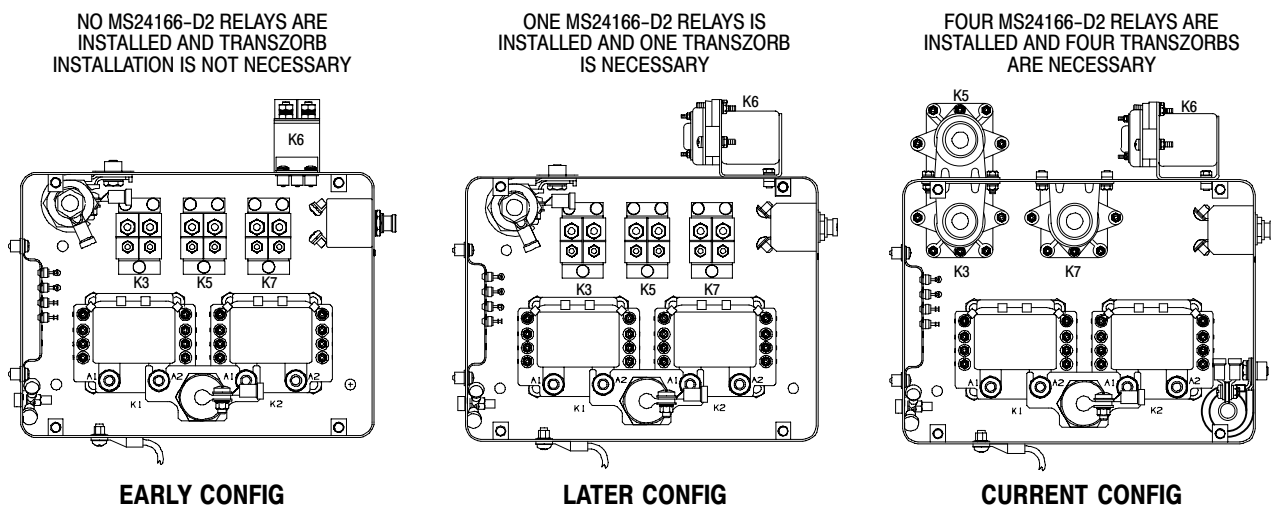
Figure 1. External Power Box Assembly Relay Configurations

- The external power box assembly (A610) is used with the forward battery installation.
 - There are three different external power box assembly configurations. The three configurations are with no MS24166-D2 relay, one MS24166-D2 relay, or four MS24166-D2 relays.
- (1). Look at the external power box assembly to find if transzorbs are necessary (Ref. Figure 1).

- Transzorbs are not necessary for the **EARLY CONFIG** external power box assembly.
- It is not necessary to remove the external power box assembly if it is the **LATER CONFIG**.

- (2). If necessary, remove external power box assembly (Ref. CSP-900RMM-3, Section 96-00-00, External Power Box Assembly Removal).
- (3). Find relays K3, K5, K6, and K7 and if necessary, install transzorb on relay (Ref. Figure 2).
- (4). If necessary, install external power box assembly (Ref. CSP-900RMM-3, Section 96-00-00, External Power Box Assembly Installation).

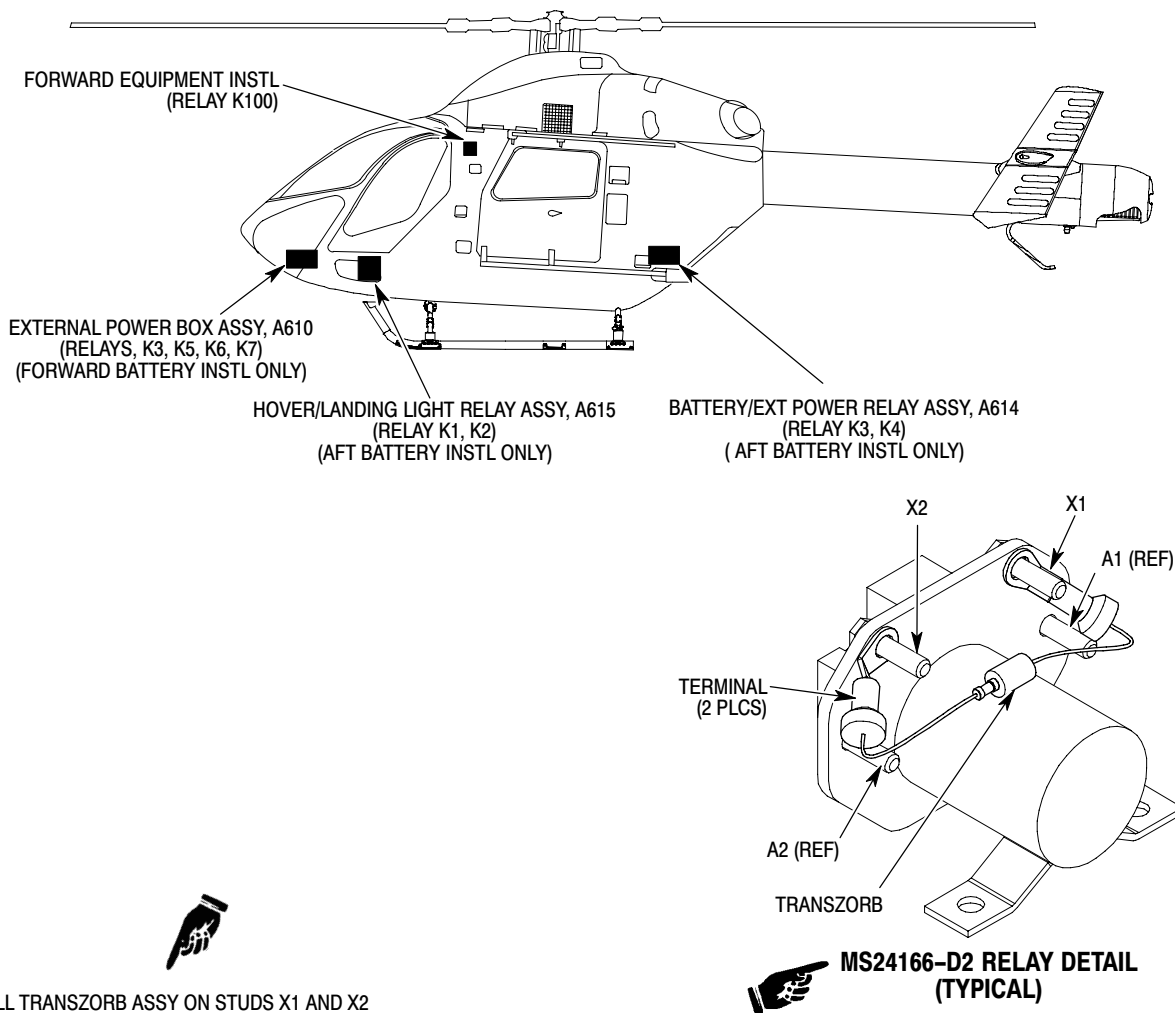
Figure 2. Electrical Noise Suppression Modification

Electromagnetic Interference (EMI) affecting a customer optional, non flight essential electronic display system in an MD900 helicopter has been reported. The source of the EMI has been identified as a relay in the hover/landing light relay assembly. The same type of relay is used in other helicopter systems. This Bulletin adds electrical noise suppression to the subject relays.

- (2). Remove bulkhead cover to access K100 power relay.
- (3). Install transzorb on K100 relay (Ref. Figure 2).
- (4). Install bulkhead cover.
- (5). Restore power to helicopter (Ref. CSP-900RMM-3, Section 96-00-00, Restore Power).

1. INSTALL TRANSZORB ASSY ON STUDS X1 AND X2
2. DO NOT BEND TERMINALS MORE THAN 90 DEGREES.
3. TRANSZORB CAN BE INSTALLED IN EACH OF THE TWO DIRECTIONS.
