# TECHNICAL BULLETIN

DATE: 26 JULY 2010  
PAGE 1 OF 6

## SECONDARY EJECTOR OIL BREATHER FITTING MODIFICATION

All MD900 Helicopters.

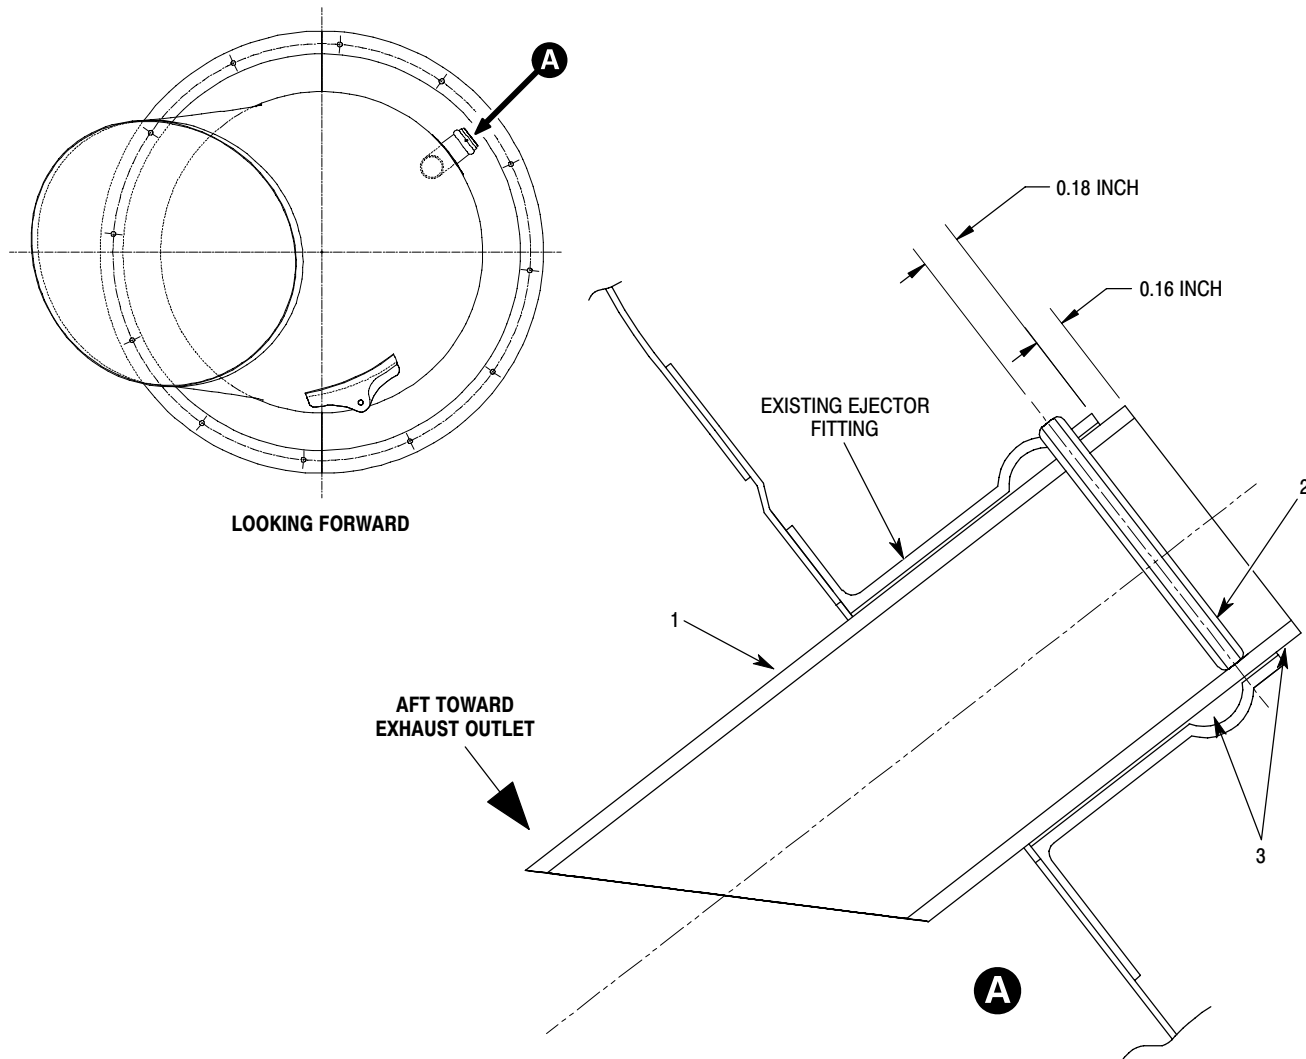
**Figure 1. Ejector Fitting Modification**

MDHI has developed a modification to the engine exhaust secondary ejector oil breather fitting to eliminate engine oil seeping back into the engine compartment and aft cowlings from the engine oil breather tube. This procedure is provided to allow operators to do this modification. There have been part changes since SL900-016.

**NOTE:** Ref. Figure 1. Incorrect orientation of tube will pressurize engine gearbox.

- (3). Apply sealant (3) (C215). (Ref. CSP-900RMM-2, Section 20-50-00, and CSP-SPM, Section 20-30-00).
  - (a). Apply to inside diameter of existing nipple at mating surface bead location with a quantity which will contact the tube outside diameter upon installation. Remove excess sealant.
  - (b). Apply a bead of sealant around outside diameter at tube (1) to nipple edge. (Ref. Figure 1, item 3 ).

- (1). Install tube (1). The 45 degree angle mouth must be positioned to face aft toward ejector outlet.
- (2). Install pin (2).
  - (a). Drill 0.122 to 0.128 inch (3.1 to 3.25 mm) diameter hole through wall of fitting and tube (orientation around outside diameter is optional) on tube centerline and to dimensions shown.
  - (b). Install (press fit) pin (2) until it bottoms out on tube inside diameter.

**NOTE:** If necessary open hole to the minimum diameter to install pin (2).

- (c). Grind off end of pin (2) flush to bead of fitting.
