[Docket No. 2001-SW-39-AD; Amendment 39-12751; AD 2002-10-05]

Airworthiness Directives; MD Helicopters Inc. Model MD-900 Helicopters

2002-10-05 MD Helicopters, Inc.: Amendment 39-12751. Docket No. 2001-SW-39-AD. Supersedes AD 2001-07-09, Amendment 39-12175, Docket No. 2000-SW-15-AD.

Applicability: Model MD-900 helicopters, with main rotor upper hub (hub) assembly, part number (P/N) 900R2101006-105 or P/N 900R2101006-107, installed, certificated in any category.

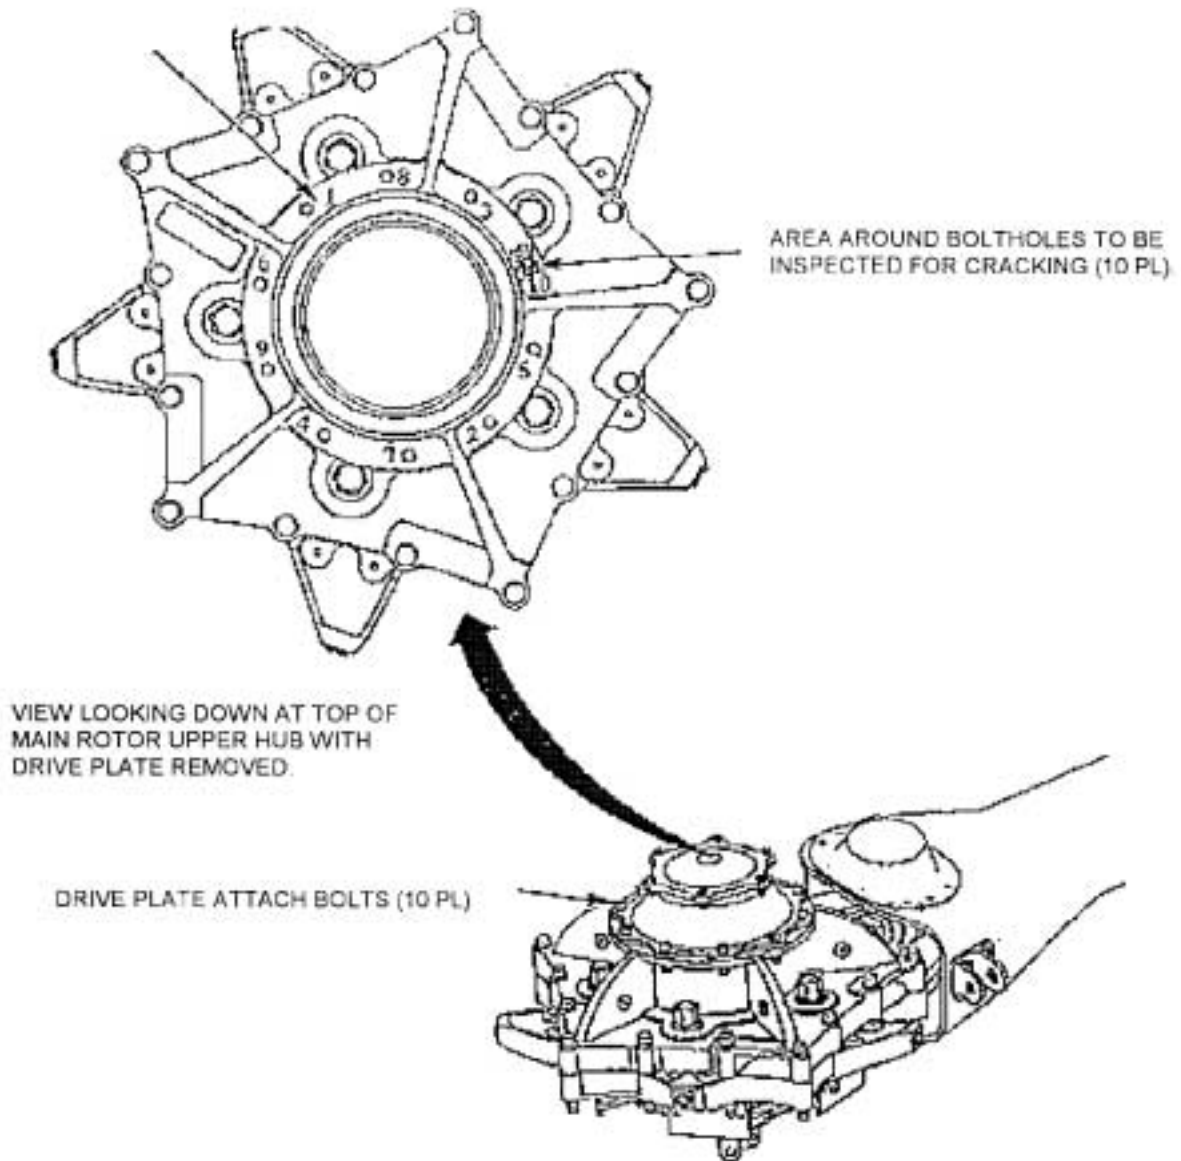
Figure 1. Main Rotor Upper Hub Assembly Inspection

SUMMARY: This amendment supersedes an existing airworthiness directive (AD), applicable to MD Helicopters Inc. Model MD-900 helicopters, that currently requires inspecting the main rotor upper hub (hub) assembly drive plate attachment flange (flange), determining the torque of each flange nut (nut), and if a crack is found, before further flight, replacing the hub assembly. In addition to the current requirements, this action requires visually inspecting the outer surface of the flange at specified intervals, removing the drive plate and visually inspecting the flange for a crack at specified intervals, and replacing any unairworthy hub assembly. This amendment is prompted by reports that cracks starting at the drive plate attachment holes were found in the hub. The actions specified by this AD are intended to detect a crack in the flange and to prevent failure of the hub assembly, loss of drive to the main rotor, and subsequent loss of control of the helicopter.

(v) Using paint stripper (Consumable Item List C313 or equivalent) and cleaning solvent (C420 or equivalent), remove the paint from the upper mating surface of the hub assembly to enable an accurate visual inspection of each drive plate attachment bolt hole (bolt hole) area for cracking (Figure 1). Ensure the paint stripper and solvent DO NOT contaminate the upper bearing and upper grease seal areas.

(vi) Using a 10x or higher magnifying glass and light, inspect the mating surface area and the area around and inside the 10 bolt holes of the hub assembly for a crack. If a crack is found, before further flight, replace the hub assembly with an airworthy hub assembly.

(ii) Mark the main rotor hub holes to correspond with the drive plate hole numbers (see Figure 1 of this AD).

(viii) Reinstall the main rotor drive plate using 10 new sets of replacement attachment hardware. Torque the nuts to 160 inch pounds above locknut locking/run-on torque in the sequence shown (Figure 1). Record in the rotorcraft logbook, or equivalent record, the locknut locking/run-on torque for each nut.

(ix) After the next flight, verify that the torque on each of the 10 nuts is at least 160 inch-pounds above the locknut locking/run-on torque (minimum torque). Re-torque as required without loosening nuts.

(x) Thereafter, at intervals of at least 4 hours TIS, not to exceed 6 hours TIS, verify that the torque of each of the 10 nuts is at least the minimum torque. Re-torque as required without loosening nuts. This torque verification is no longer required after the torque on each of the 10 nuts has stabilized at a torque value of 160 or more inch-pounds for each nut during two successive torque verifications.
