[Docket No. 2001-SW-40-AD; Amendment 39-12793; AD 2002-13-05]

Airworthiness Directives; MD Helicopters, Inc. Model 369D, 369E, 369F, and 369FF Helicopters

2002-13-05 MD Helicopters, Inc.: Amendment 39-12793. Docket No. 2001-SW-40-AD.

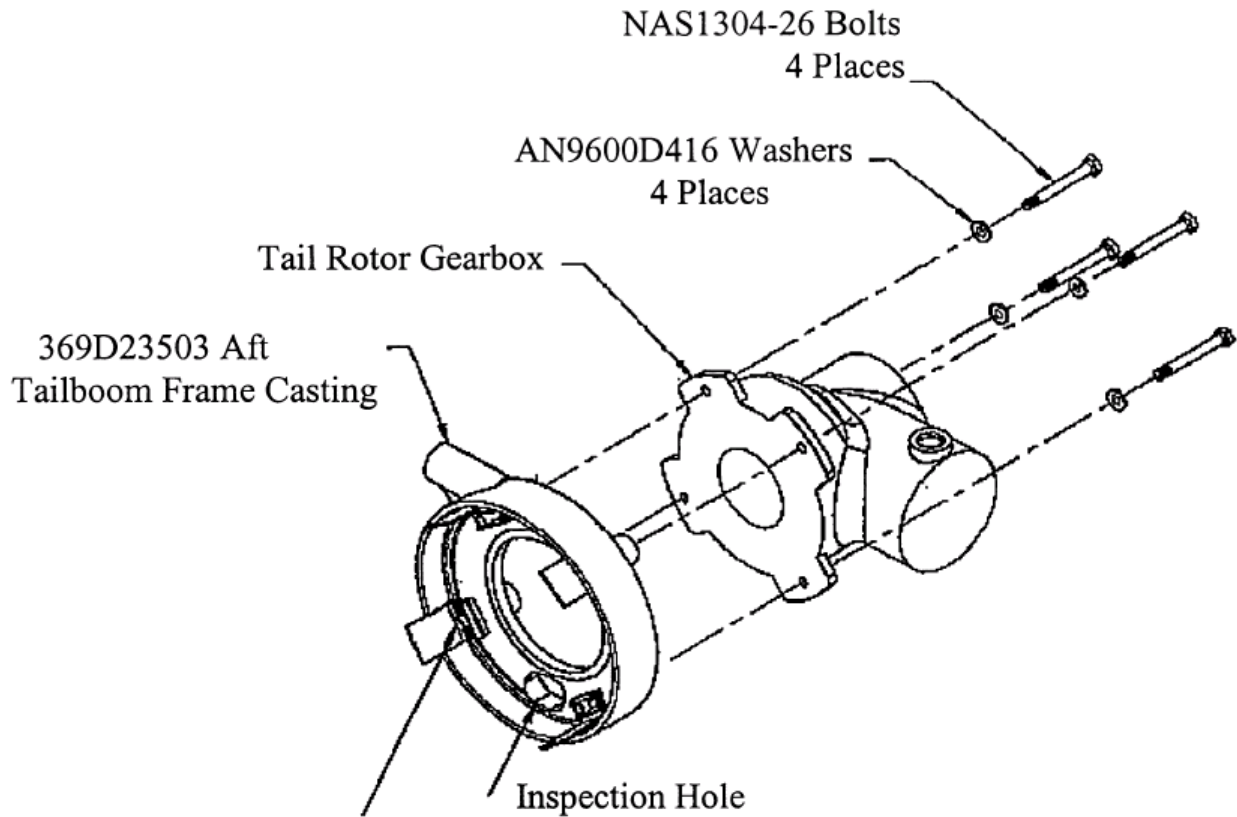
Figure 1 - Inspection Location

To prevent loss of the tail rotor gearbox due to attaching bolts of inadequate grip length and subsequent loss of helicopter control, accomplish the following:

(2) Remove the tailboom control rod and determine the number of bolt threads protruding from each nutplate on the internal surface of the aft tailboom frame casting, P/N 369D23503, as shown in Figure 1 of this AD. At least one thread must protrude. If more than four threads protrude, add an additional washer, P/N AN960D416, under the bolt head. Torque the bolt to 100-110 in-lbs, and reapply a slippage mark. See Figure 1:

Inspect this area of each bolt.
 Bolt must protude at least one
 thread past end of nutplate
 4 places.

(ii) If the P/N cannot be determined or if the bolt is not P/N NAS1304-26, before further flight, replace the bolt with bolt, P/N NAS1304-26.

(iii) Torque the bolt to 100-110 in-lbs and apply a slippage mark.

(b) Between 2 and 10 hours TIS after accomplishing the requirements of paragraph (a) of this AD, inspect the torque on each bolt by applying 100 in-lbs. If any bolt movement occurs, retorquing the bolt to 100-110 in-lbs and reapply a slippage mark. Reinspect the torque between 2 and 10 hours TIS thereafter until no bolt movement occurs.
