FAA Airworthiness Directive

90-24-07 MCDONNELL DOUGLAS HELICOPTER COMPANY (MDHC): Amendment 39-6784. Docket Number 90-ASW-10. Applicability: All MDHC Model 369D, 369E, and 369F/FF series helicopters certificated in any category.

AD 90-24-07

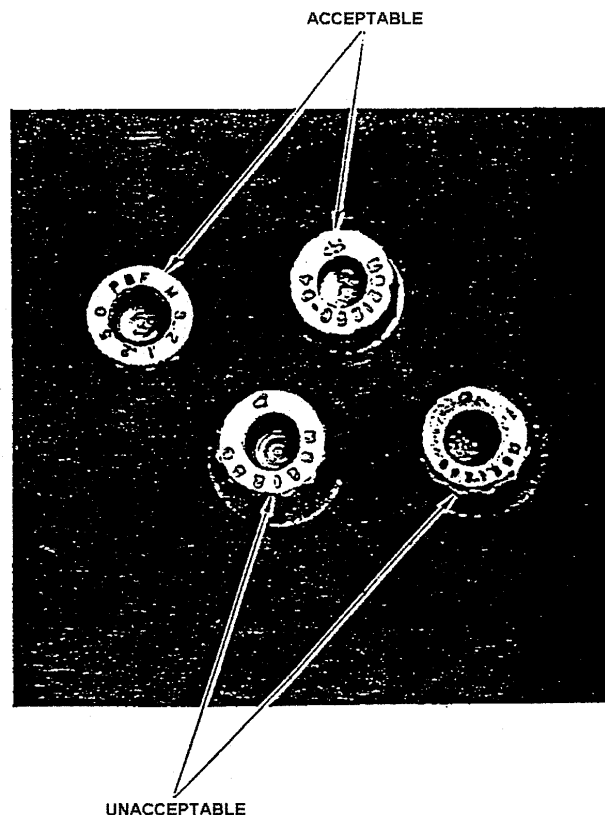
Figure 1. Inspection/Definition of Bolt Heads.

To prevent possible failure of the main rotor transmission drive assembly, which could result in loss of control of the helicopter, accomplish the following:

(a) Within the next 300 hours' time in service after the effective date of the AD or at the next annual inspection or the next time the transmission is removed, whichever occurs first, after the main rotor transmission is removed inspect the MS21250-04036 bolts which retain the debris cover, P/N 369D25174. Remove any bolts with the head inscription shown as unacceptable in Figure 1, and replace with MS21250-04038 bolts, which have a length of 2.887 plus/minus 0.010 inch.

(b) Inspect the thread protrusion of all bolts. Remove any bolt which does not protrude through the H14-4 nut for a length equivalent to two full threads (0.071 inch minimum), including the chamfer. Replace removed bolts with MS21250-04038 bolts. Torque the bolts to 50-70 inch pounds. Verify that the bolts protrude through the nut for a length equivalent to two full threads (0.071 inch minimum), including the chamfer. If more than four threads protrude through the nut, add AN960C416L or AN960C416 washers under the nut as required. Remove and reinstall parts in accordance with the manufacturer's instructions.
