FAA Airworthiness Directive

91-08-02 MCDONNELL DOUGLAS HELICOPTER COMPANY (MDHC) (HUGHES): Amendment 39-6963. Docket No. 90-ASW-53.

Applicability: All MDHC Model 369 series helicopters, certificated in any category.

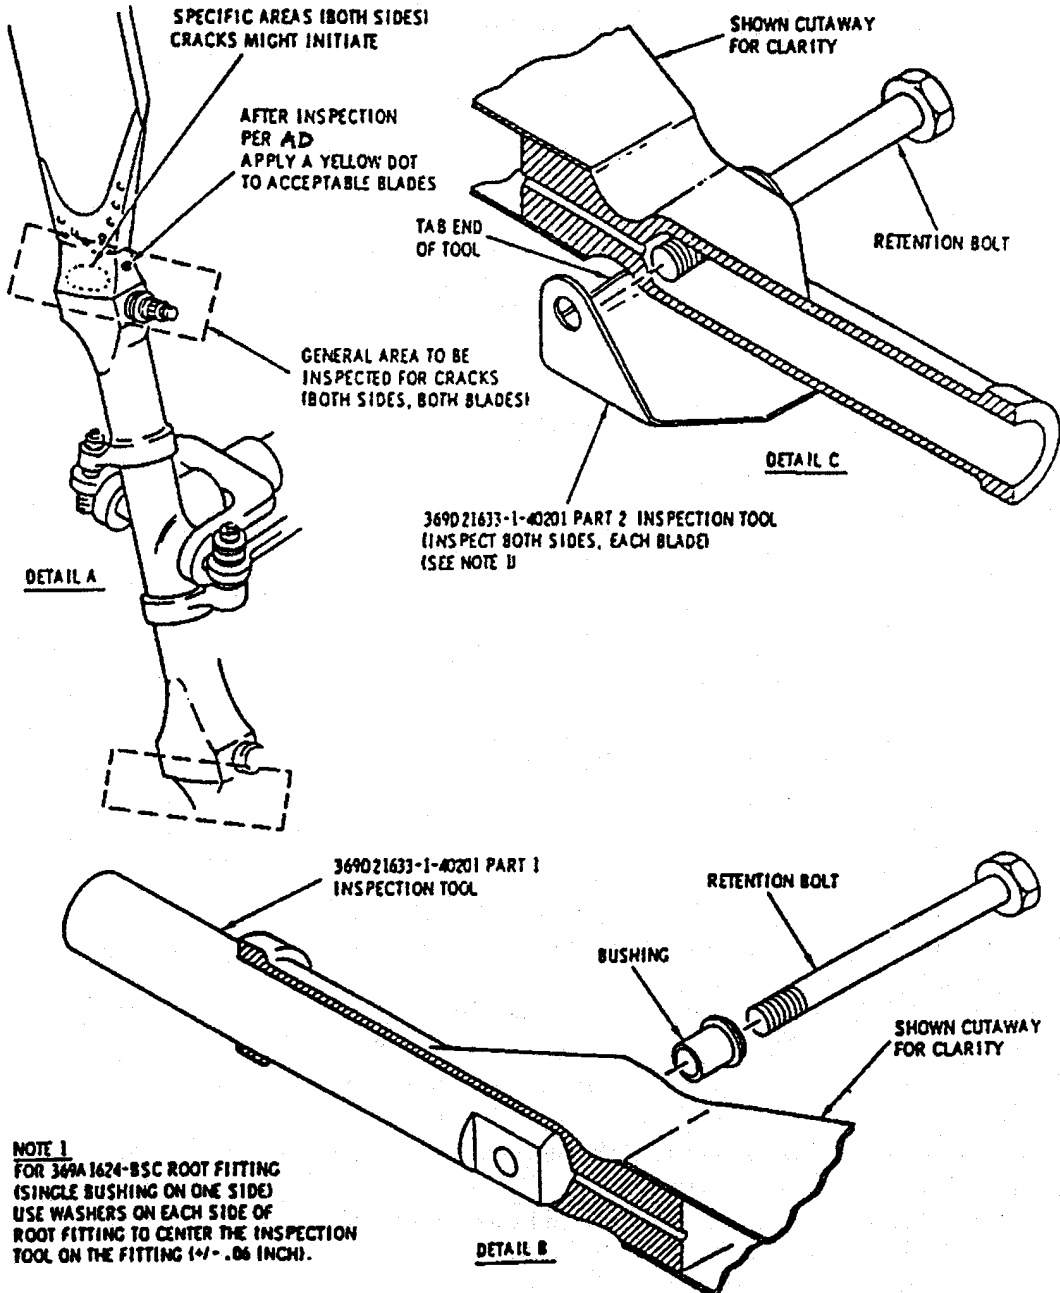
Figure 1. Inspection of Tail Rotor Blade Root Fitting.

To detect or prevent cracks in the tail rotor blade root fitting, which could result in tail rotor blade failure and subsequent loss of the tail rotor blade, accomplish the following:

(c) Within 8 hours time in service, after the effective date of this AD and, thereafter, prior to the first flight of each day, conduct a check of each tail rotor blade that fits the criteria outlined in paragraph (a). Visually check both sides of the tail rotor fitting for cracks in the area shown in Figure 1, Detail A. Replace any cracked blades with airworthy parts before further flight.

(vi) Replace unairworthy blades with airworthy blades. Replacement blades must comply with this AD.

(viii) Apply a yellow dot to airworthy tail rotor blades on the trailing edge of the root fitting approximately one-half inch outboard from the bushing. (See Figure 1, Detail A.) Record compliance by part number and serial number in the helicopter log book.
