DN-148.1\*  
EN-36.1\*  
FN-25.1\*

# SERVICE BULLETIN

DATE: 30 OCTOBER 1987  
PAGE 1 OF 6

**SUBJECT:** INSPECTION OF MAIN TRANSMISSION OUTPUT SHAFT ASSEMBLY RING GEAR CARRIER (P/N 369D25132-BSC or -5).

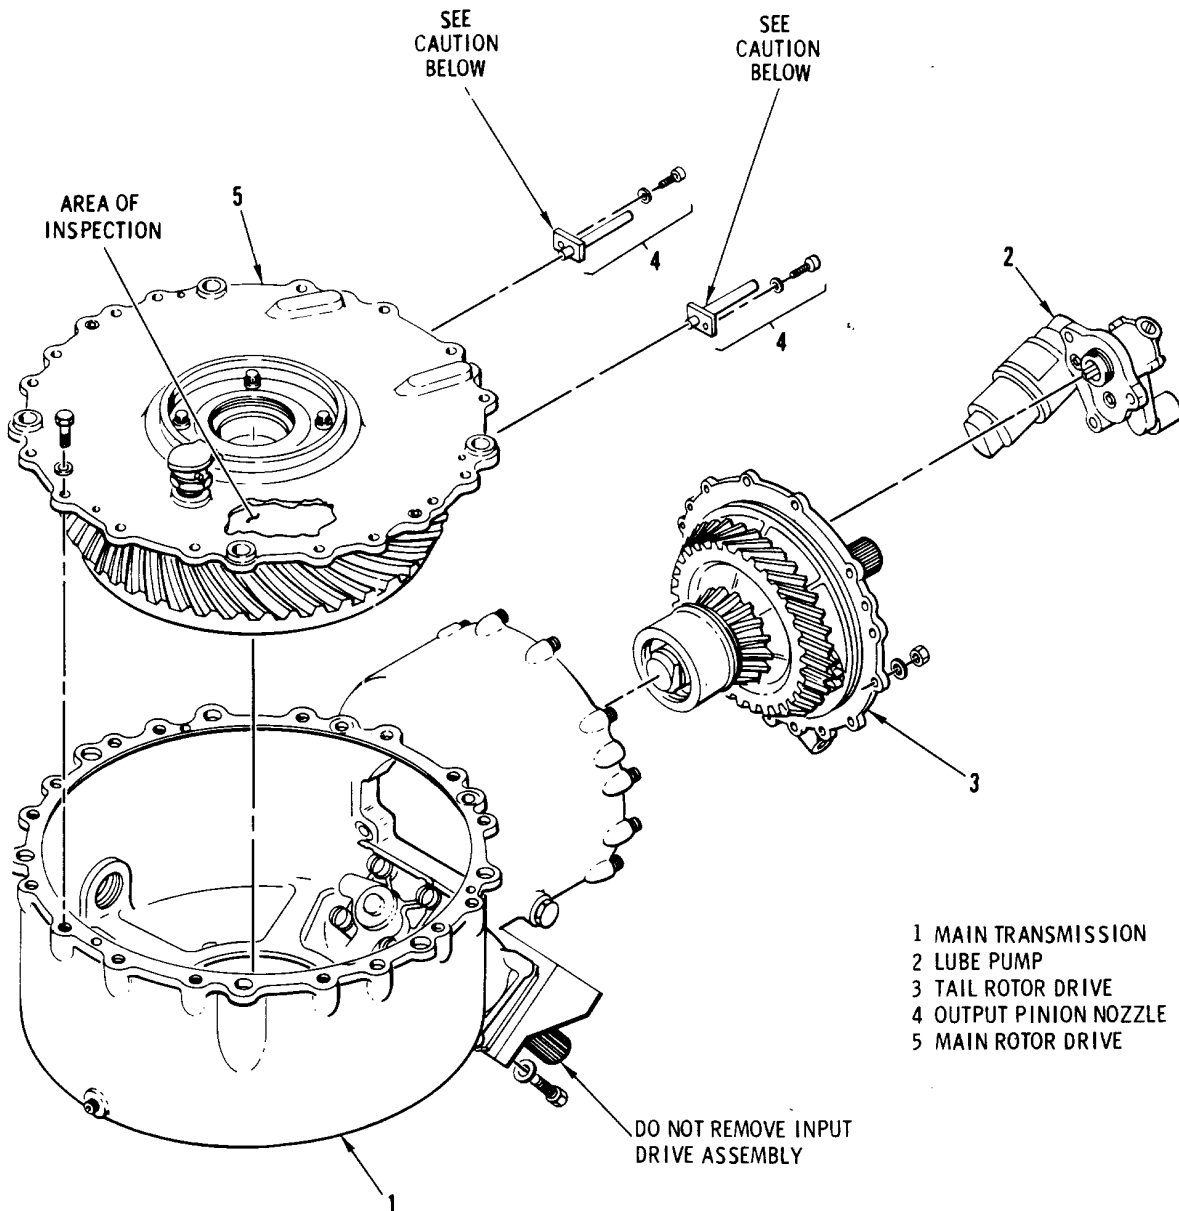
88-633

CAUTION: OUTPUT PINION NOZZLE ASSEMBLIES (4) MUST BE REMOVED BEFORE REMOVING MAIN ROTOR DRIVE ASSEMBLY (5). IDENTIFY NOZZLE ASSEMBLIES (4) TO REINSTALL EACH NOZZLE IN SAME LOCATION
