HN-226.1  
DN-172.1  
EN-63.1  
FN-51.1

# SERVICE BULLETIN

DATE: 4 SEPTEMBER 1990  
PAGE 1 OF 3

**SUBJECT:** ONE-TIME INSTALLATION OF 369D24054-3 WARNING DECALS IN THE ENGINE COMPARTMENT AREA

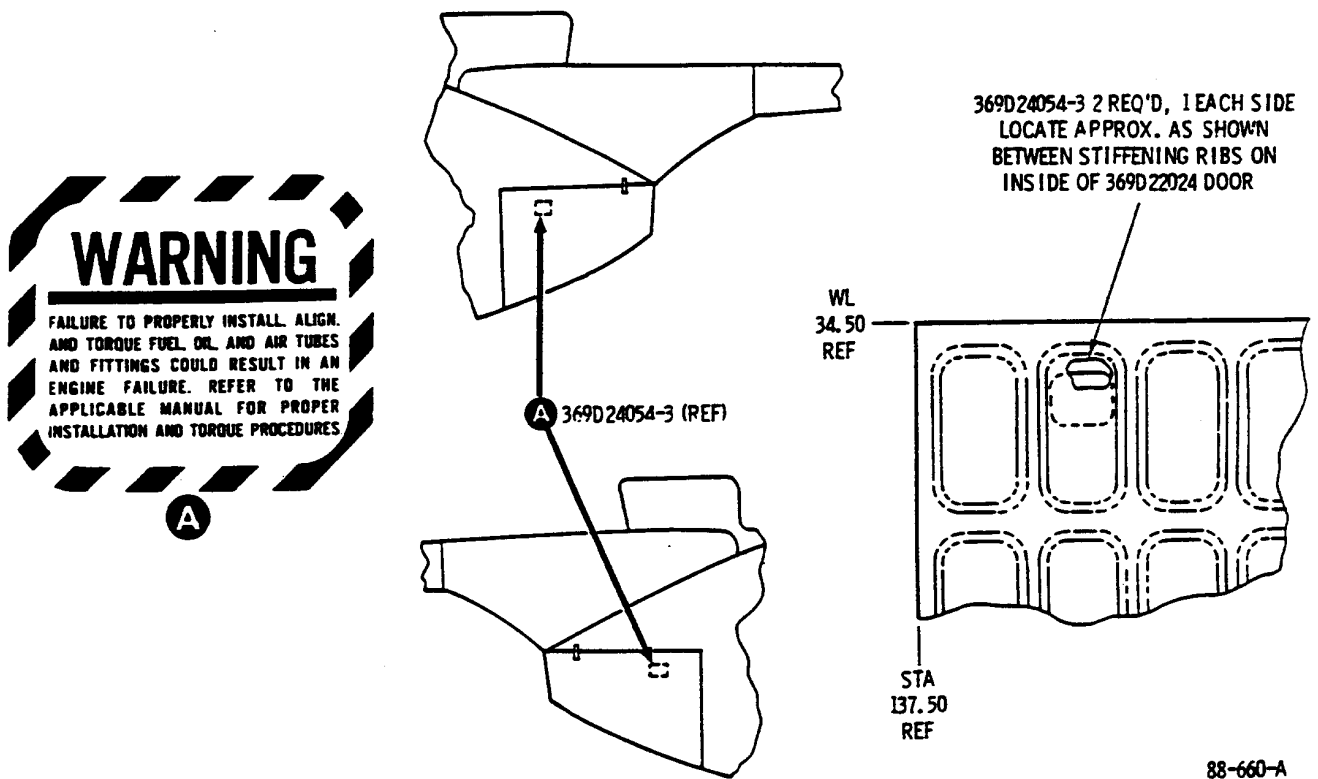
Figure 1. Engine Compartment Warning Decal Installation.

- a. Gain access to inside of the engine compartment.
- b. Verify that 369D24054-3 warning decals are installed as shown in Figure 1. If warning decals are installed, no further action is required.
- c. Ensure surface where decals are going to be installed is clean and free of oil prior to installation. Install warning decals at locations shown in Figure 1.
- d. Secure engine access door.
